INSPECTION REPORT

For the Property at:
23730 KELLY RD
EASTPOINTE, MI

Prepared for: EDDIE SADIK
Inspection Date: Tuesday, February 25, 2014
Prepared by: Christopher Daggy

Report No. 1781

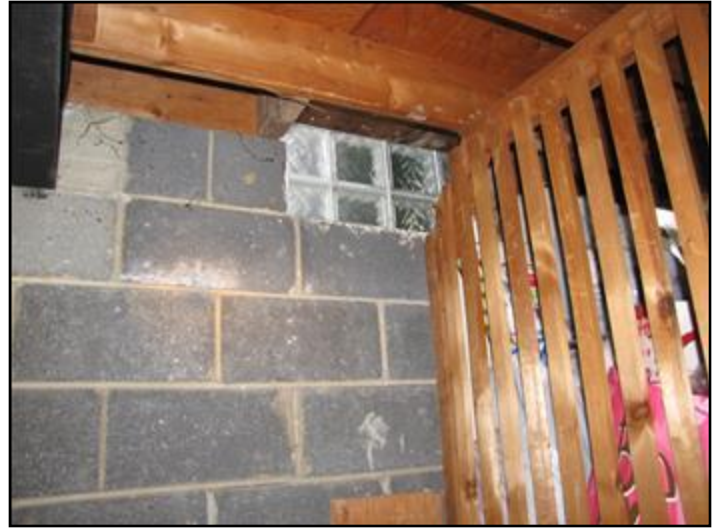
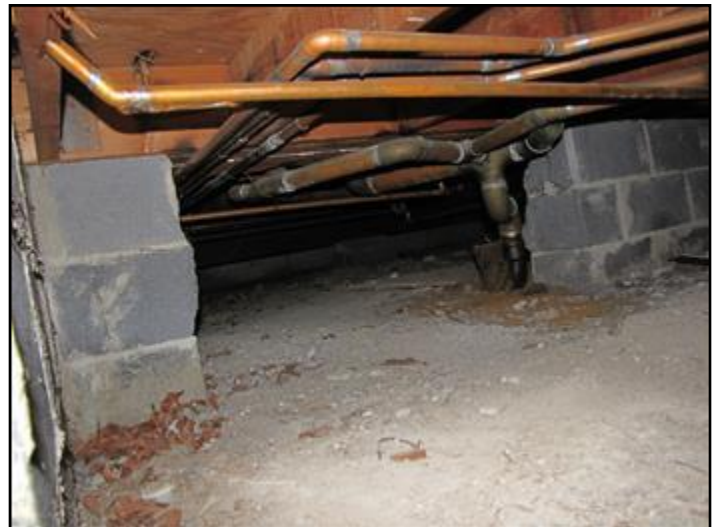
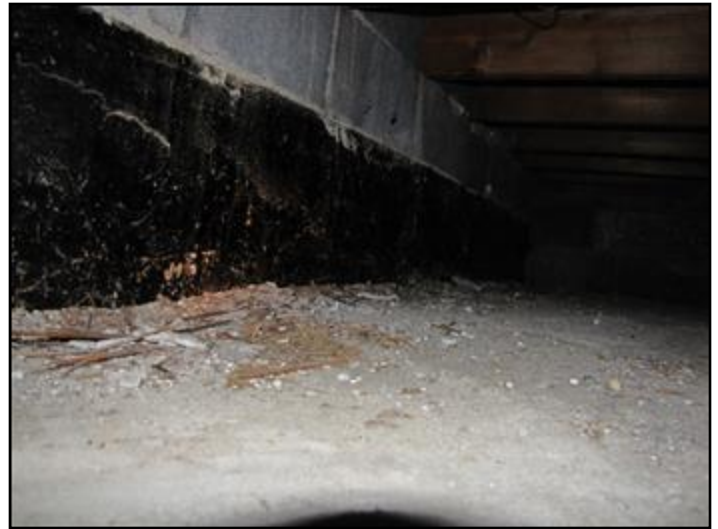
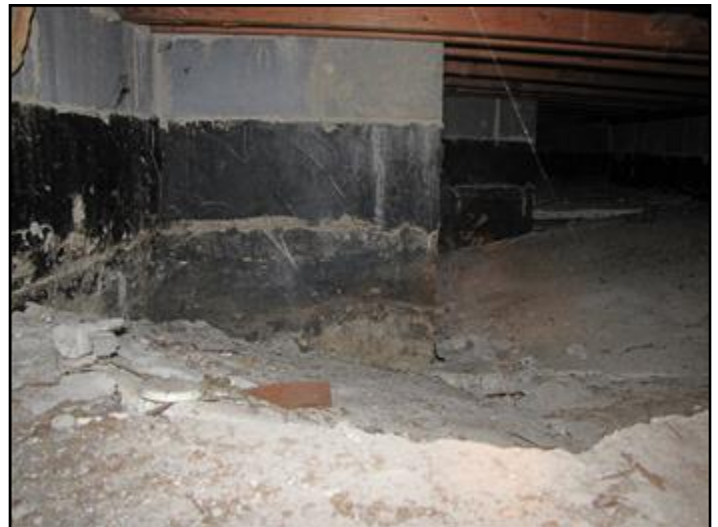
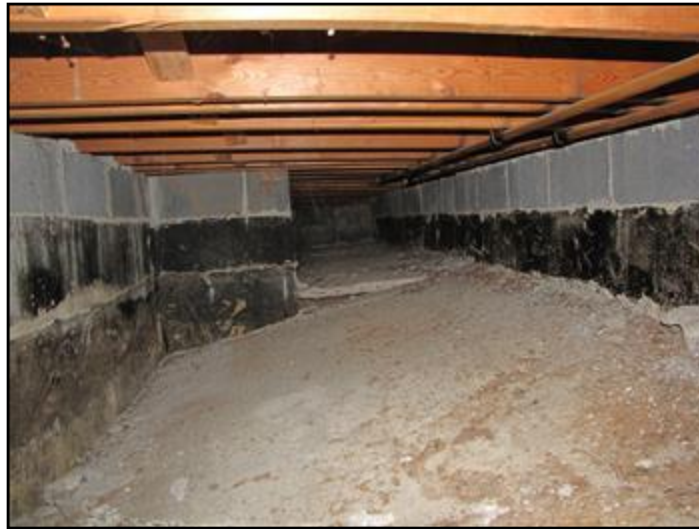
Condition: • [Settled](#)

Extensive settlement noted. This includes the basement and crawl space area. Suspect movement will continue.

1. Settled

2. Settled

3. Settled

4. Settled

5. Settled

6. Settled

7. Settled

8. Settled

9. Settled

Repairs could be extensive to stabilize and correct prior movement. Recommend review by a professional engineer that specializes in structures.

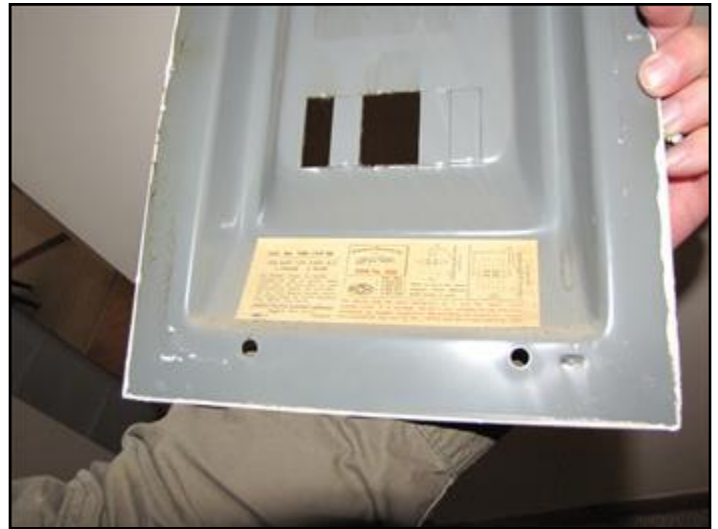
10.

Condition: • [Federal Pacific Panels utilized. These panels are linked with fire concerns. See attached link. Have panels reviewed by a licensed electrician. Replace panels if recommended.](#)

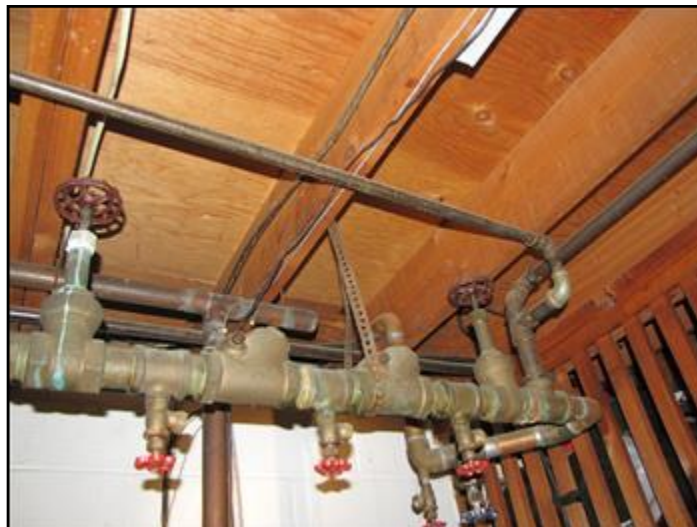
13.

- Fire suppression system not included in building inspection. Recommend review of system.

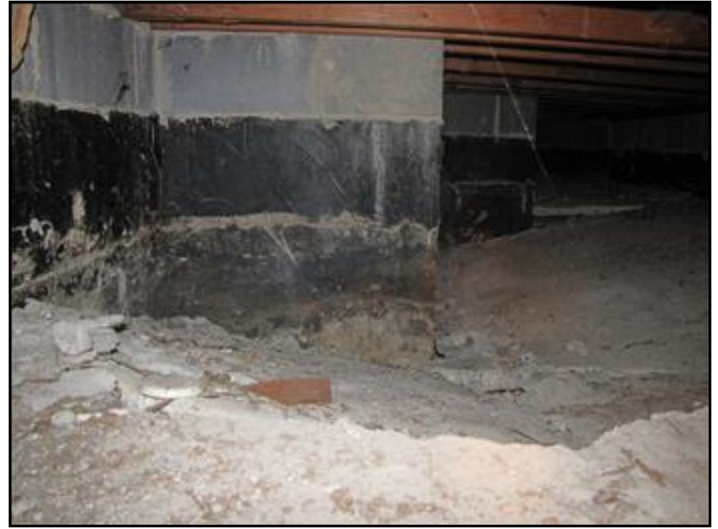
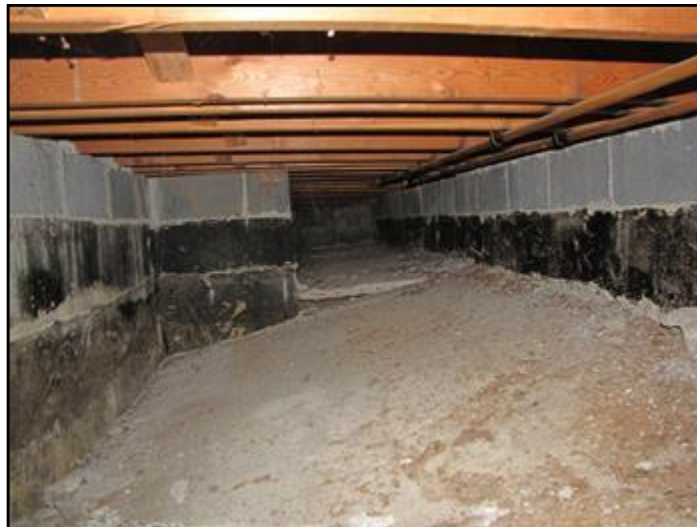
9. Condition: • [Settled](#)

Extensive settlement noted. This includes the basement and crawl space area. Suspect movement will continue. Repairs could be extensive to stabilize and correct prior movement. Recommend review by a professional engineer that specializes in structures.

47. Settled

48. Settled

49. Settled

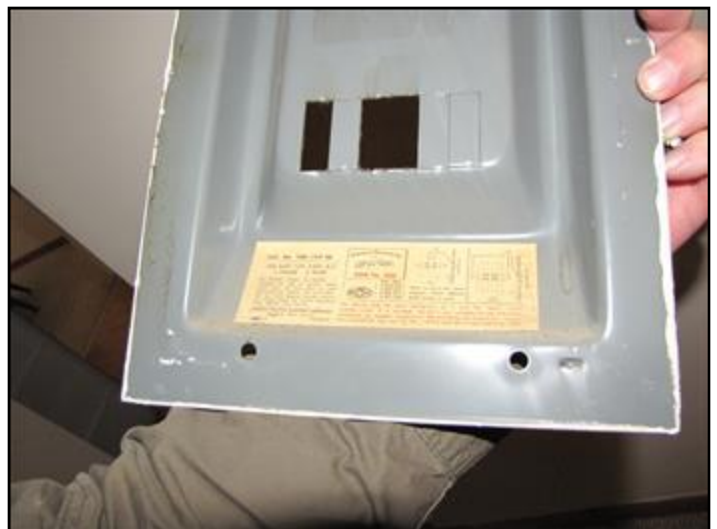
57.

14. **Condition:** • [Federal Pacific Panels utilized. These panels are linked with fire concerns. See attached link. Have panels reviewed by a licensed electrician. Replace panels if recommended.](#)
