INSPECTION REPORT

For the Property at:
123 MAIN ST
BLOOMFIELD HILLS, MI 48304

Prepared for: ANN SMITH
Inspection Date: Monday, November 2, 2015
Prepared by: Christopher Daggy

Report No. 2217, v.3

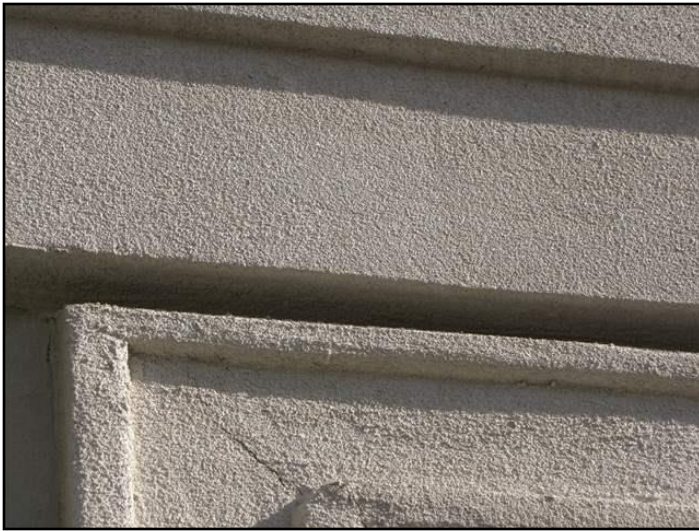
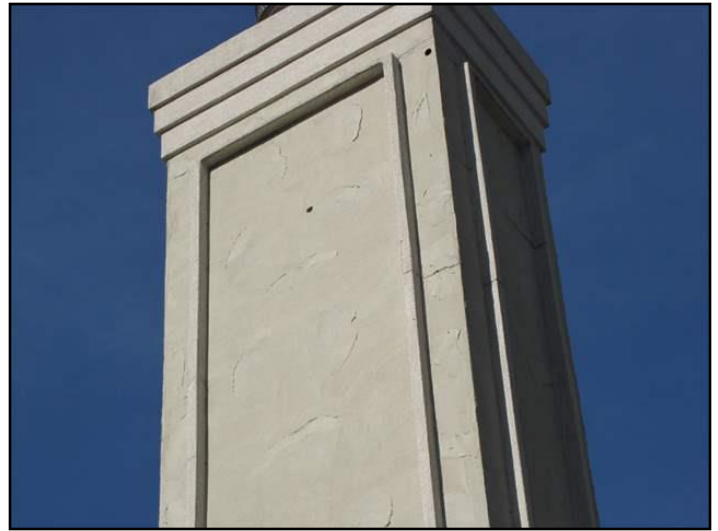
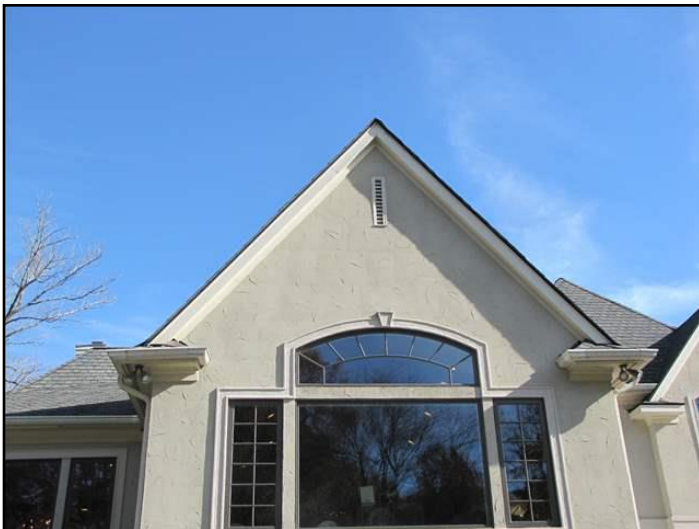
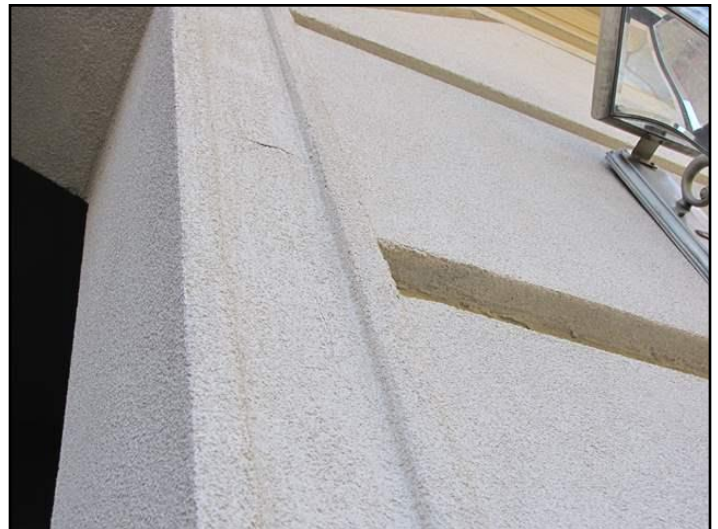
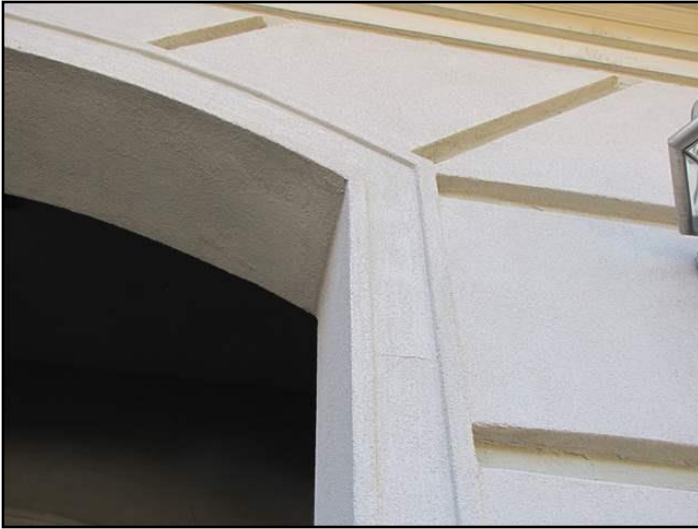
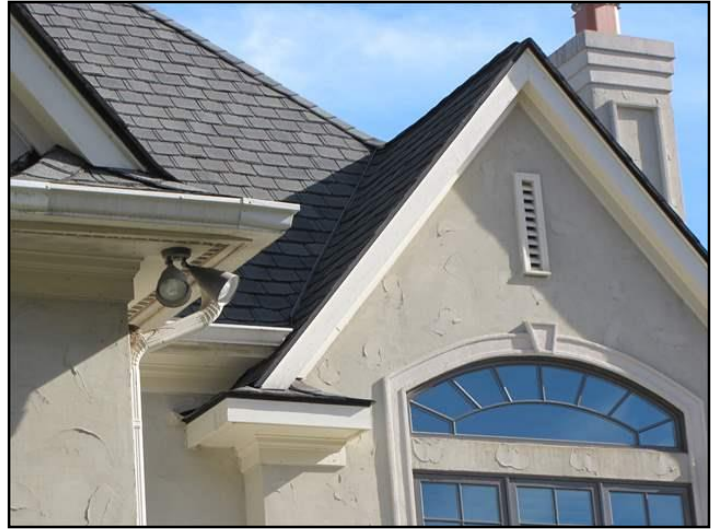
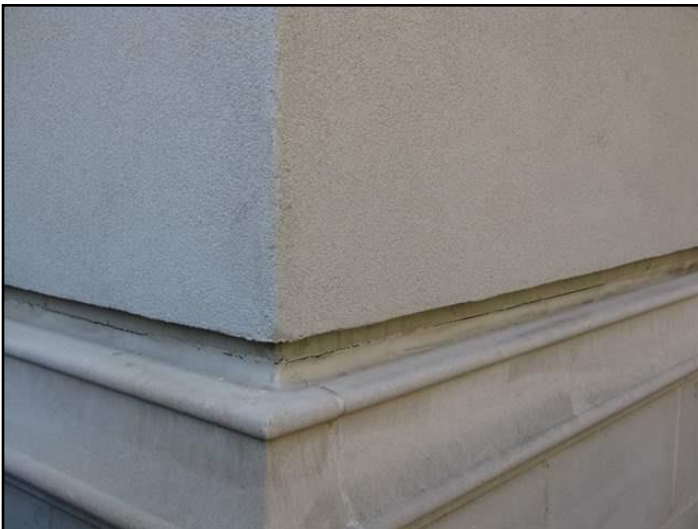
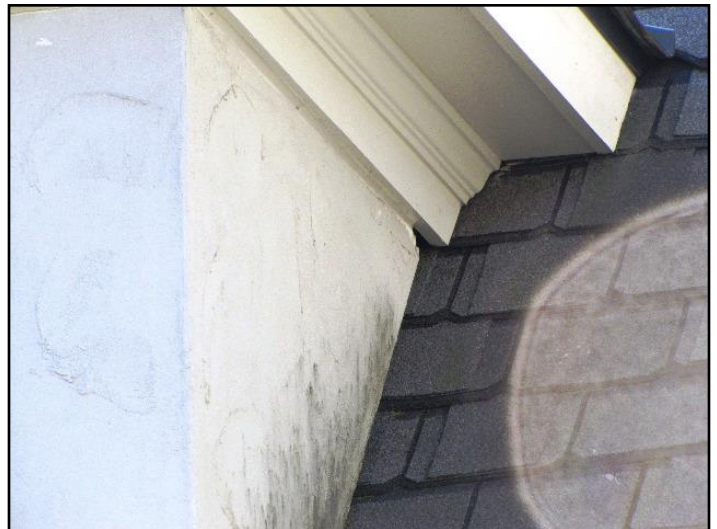
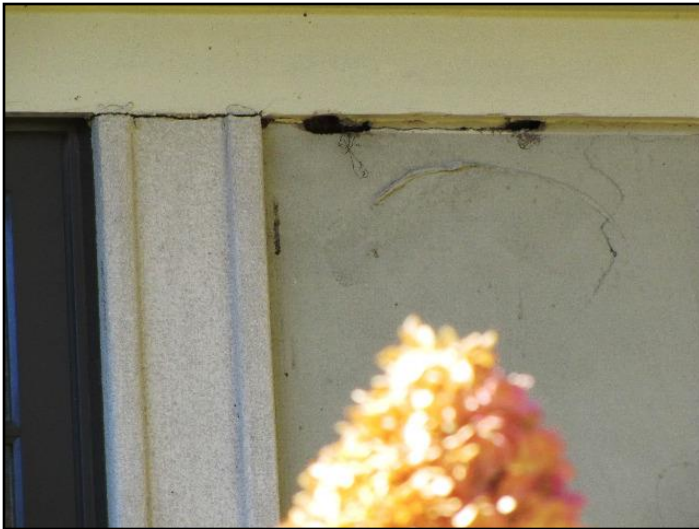
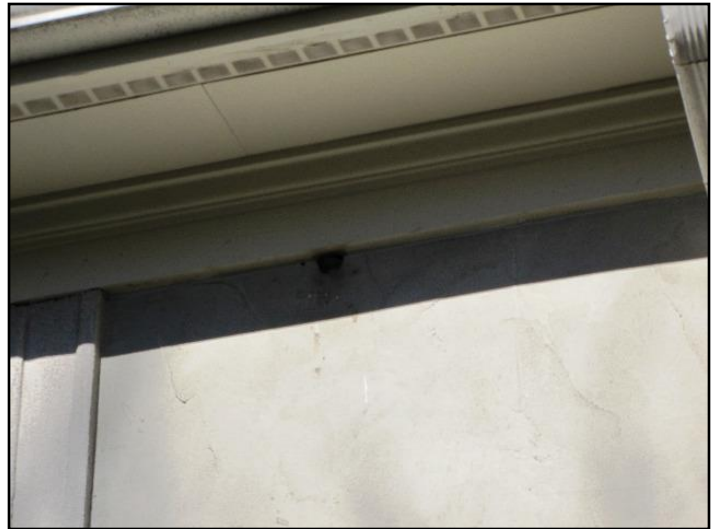
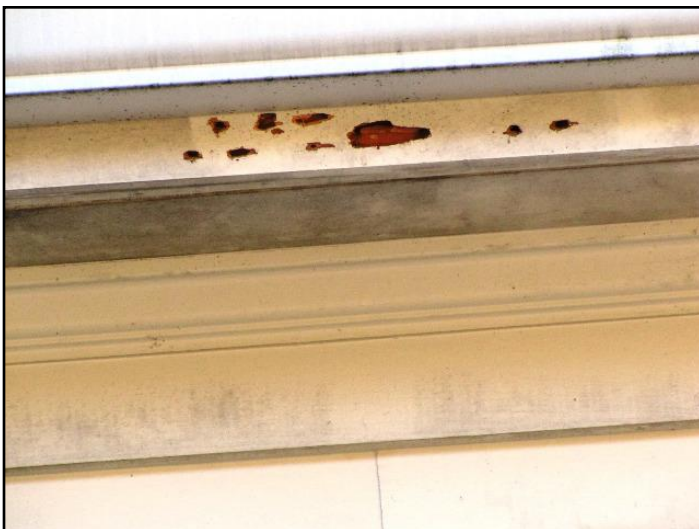
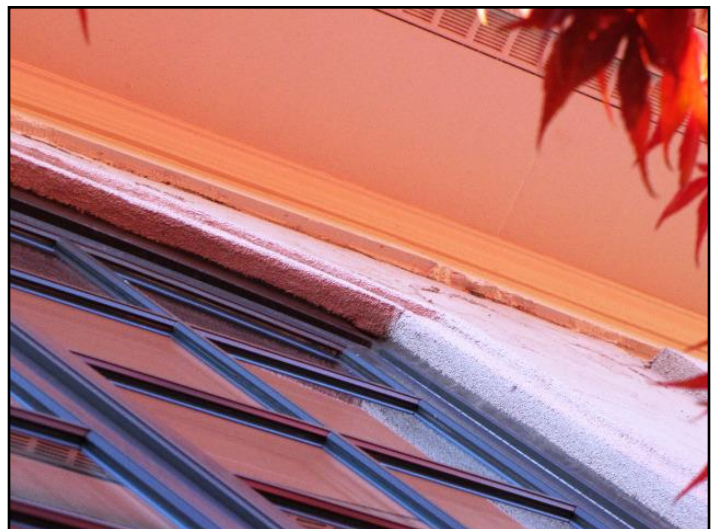
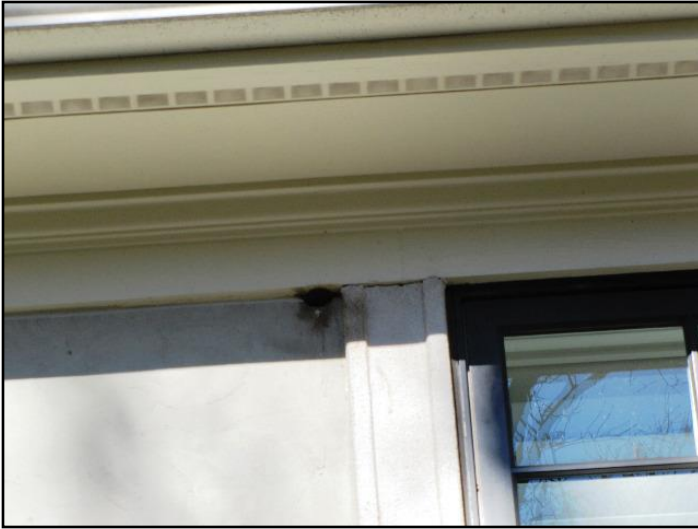
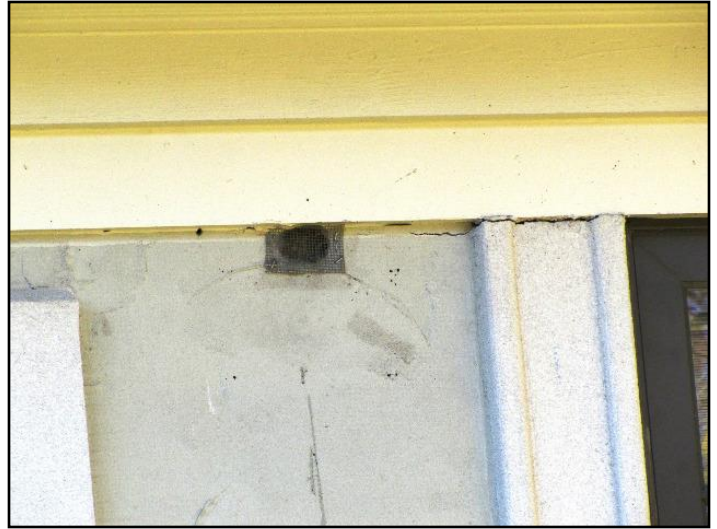
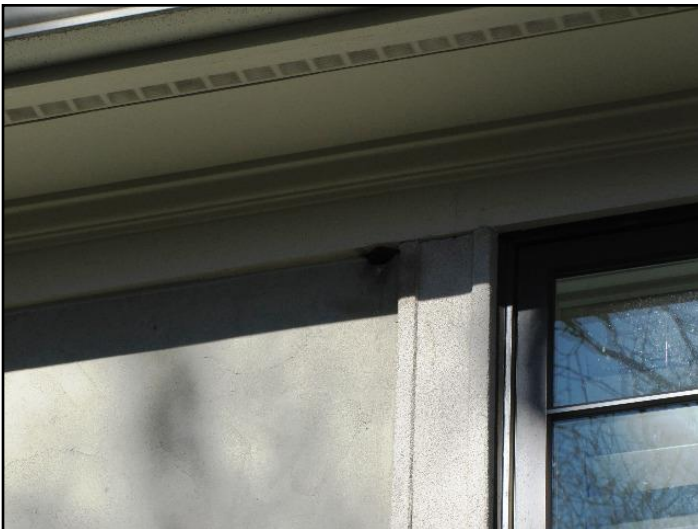
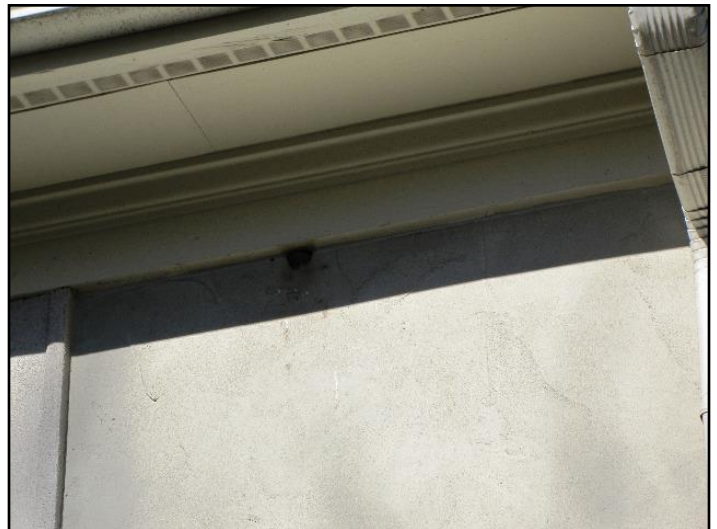
Condition: • [Cracked](#)

Implication(s): Chance of water damage to contents, finishes and/or structure | Material deterioration

Task: Further evaluation

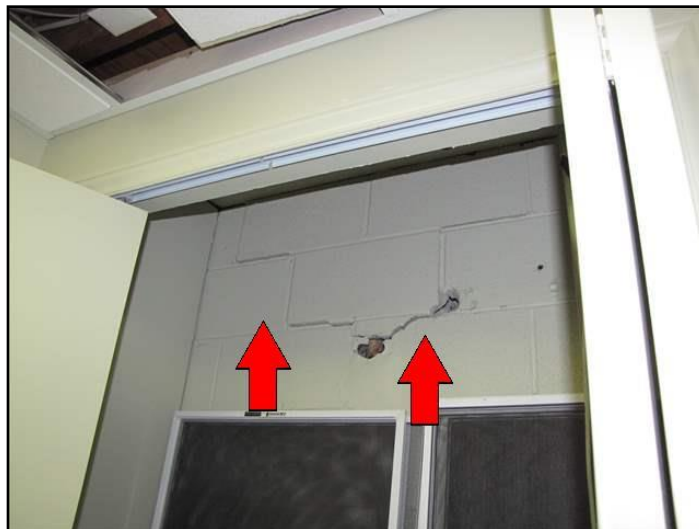
17. Mechanical damage

Condition: • [Mechanical damage](#)

Task: Repair

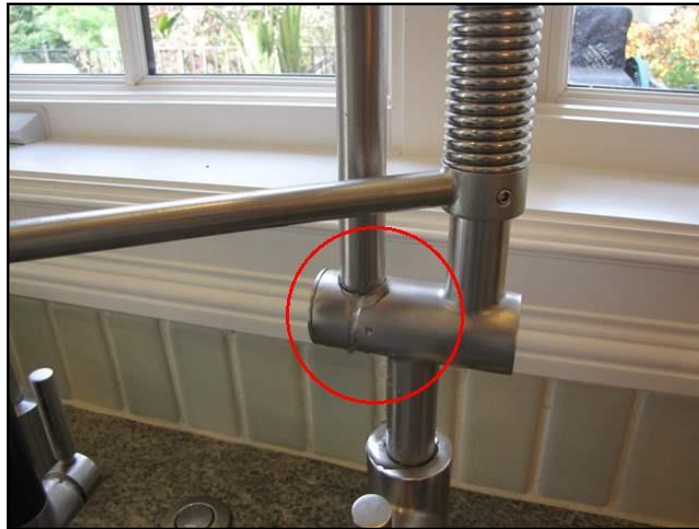
21. Drip, leak

Condition: • [Drip, leak](#)

Implication(s): Chance of water damage to contents, finishes and/or structure

Task: Repair

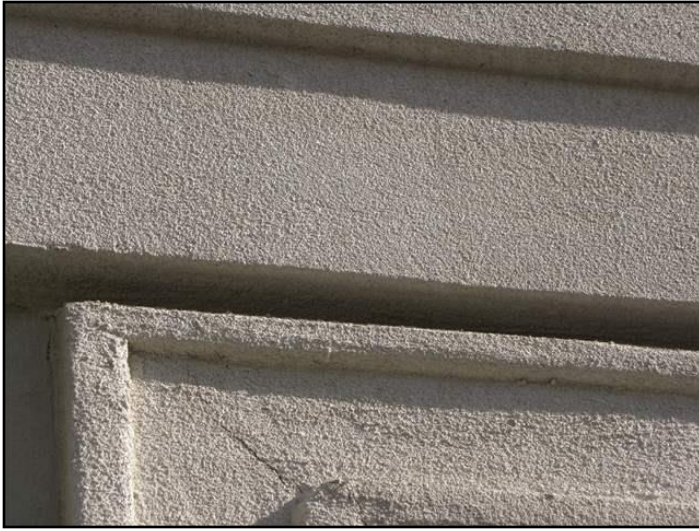
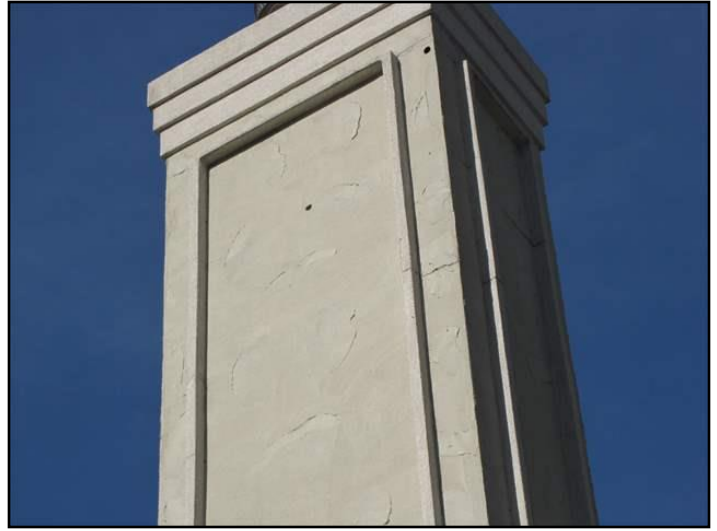
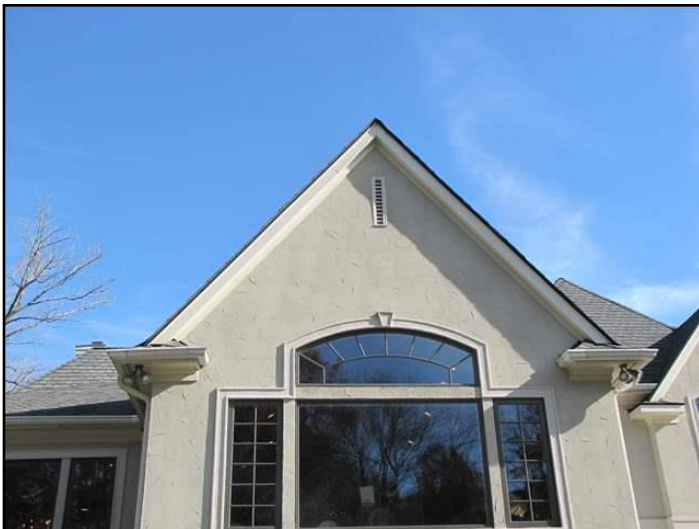
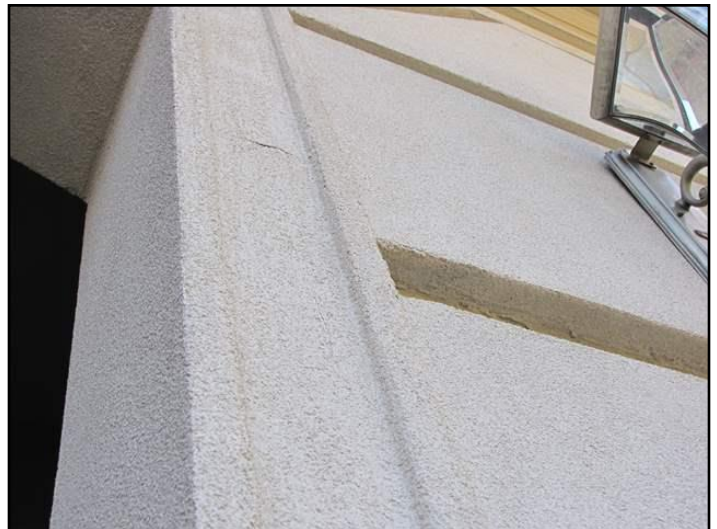
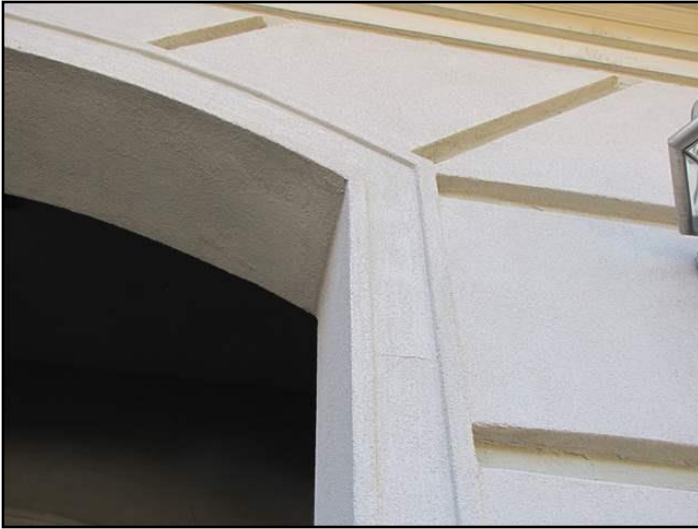
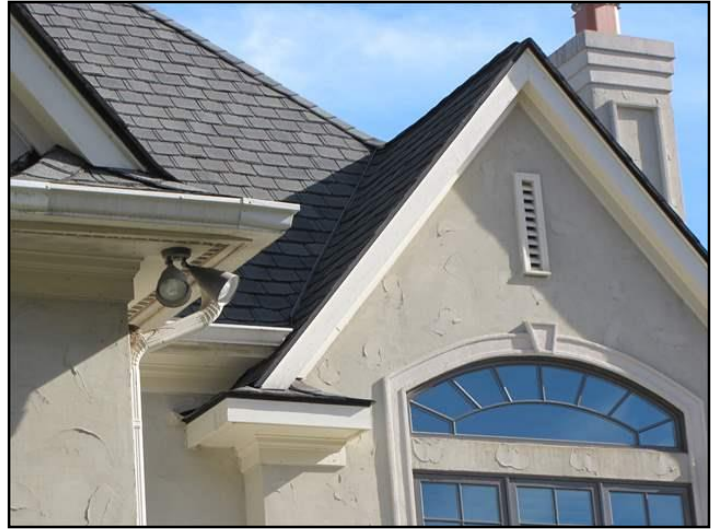
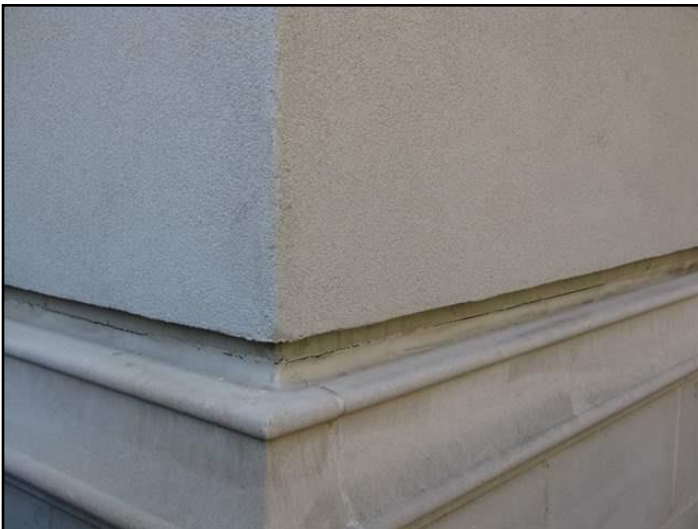
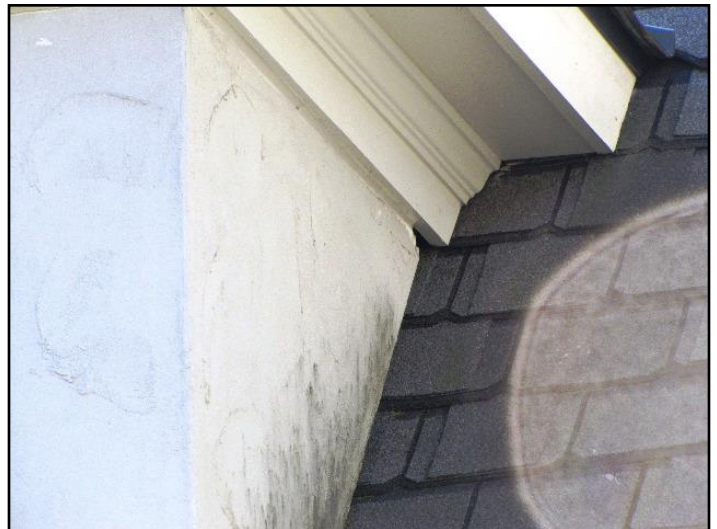
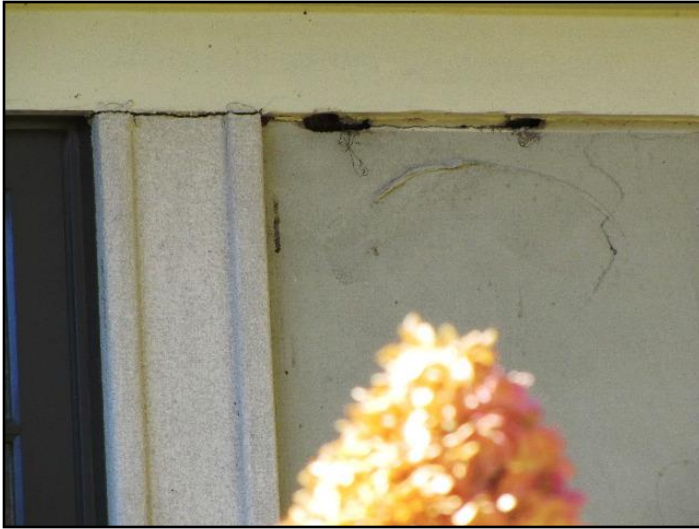
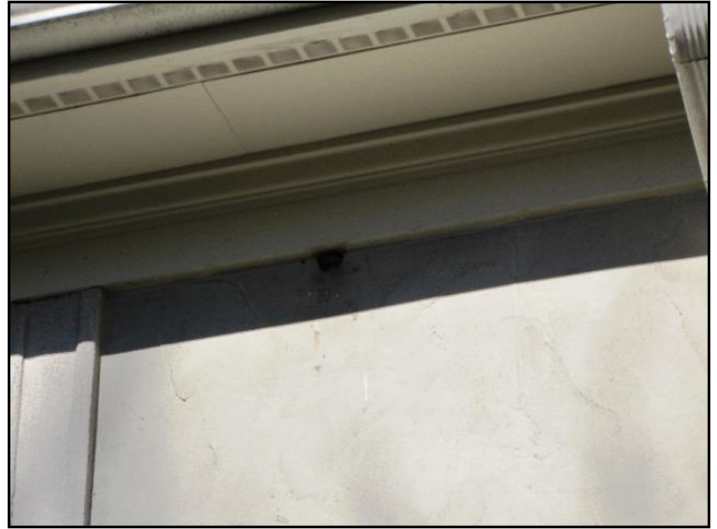
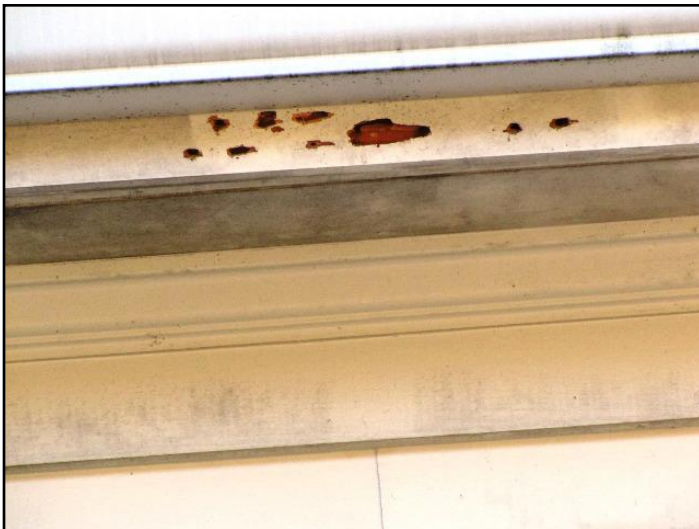
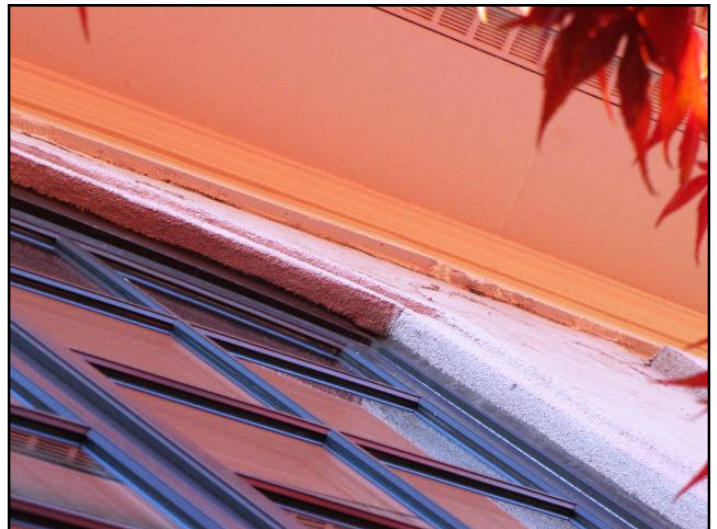
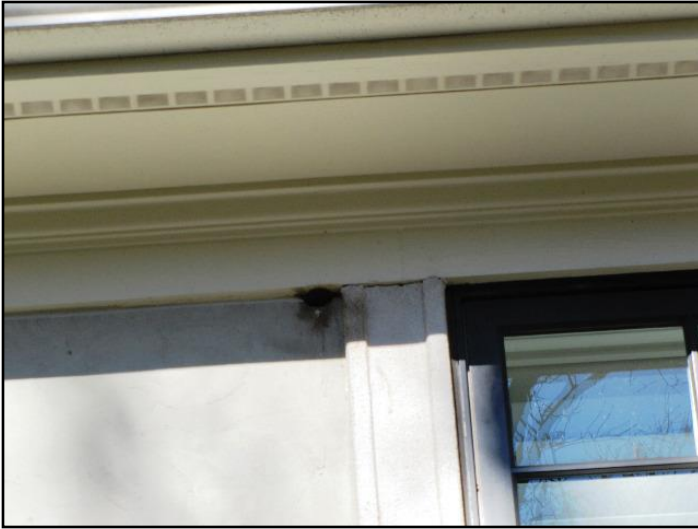
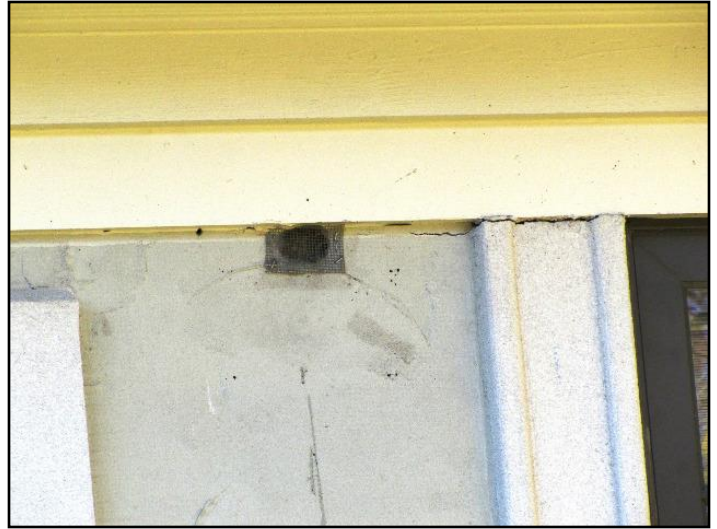
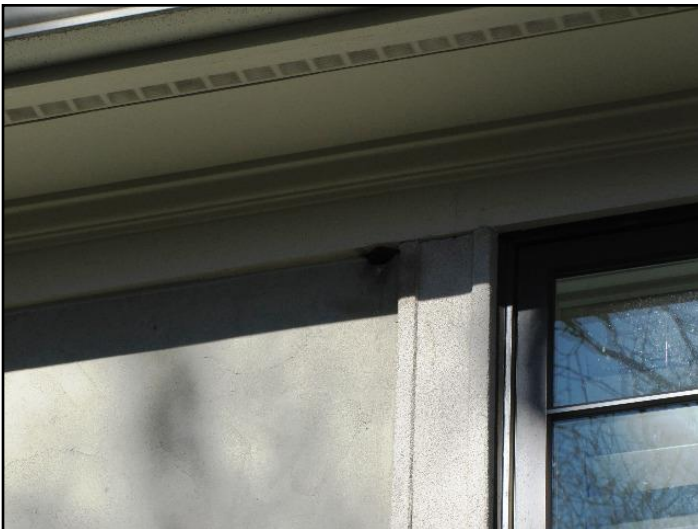
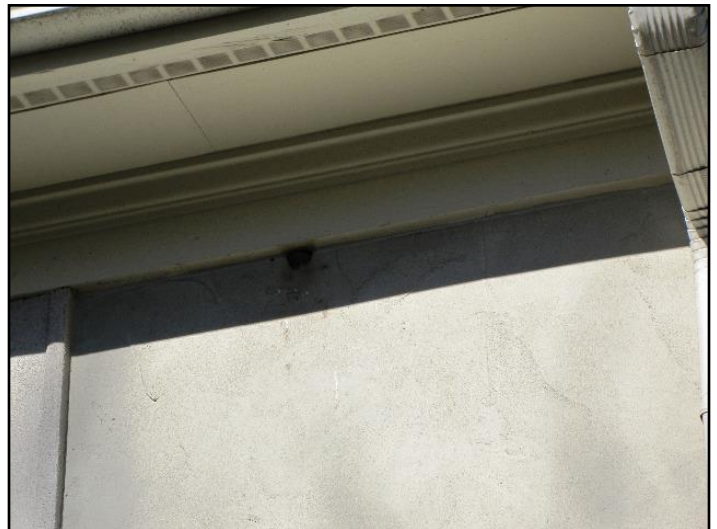
12. Condition: • [Cracked](#)

Implication(s): Chance of water damage to contents, finishes and/or structure | Material deterioration

Task: Further evaluation

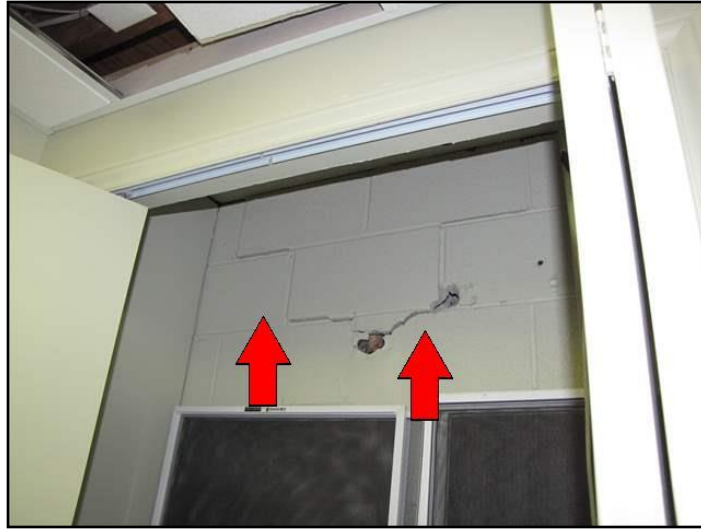
73. *Mechanical damage*

18. Condition: • [Mechanical damage](#)

Task: Repair

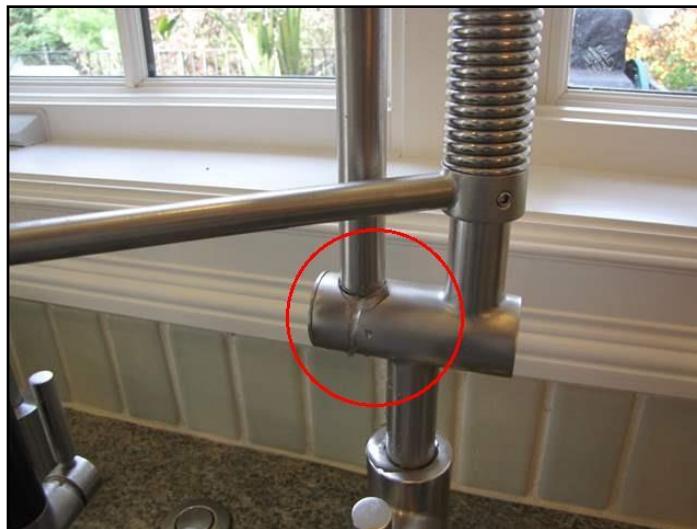
137. *Drip, leak*

35. Condition: • [Drip, leak](#)

Implication(s): Chance of water damage to contents, finishes and/or structure

Task: Repair
