INSPECTION REPORT

For the Property at:
123 Sample St.
FARMINGTON HILLS, MI 48335

Prepared for: John Doe
Inspection Date: Thursday, October 14, 2010
Prepared by: Christopher Daggy

RE: Report No. 1016
123 Sample
Farmington Hills, MI
48335

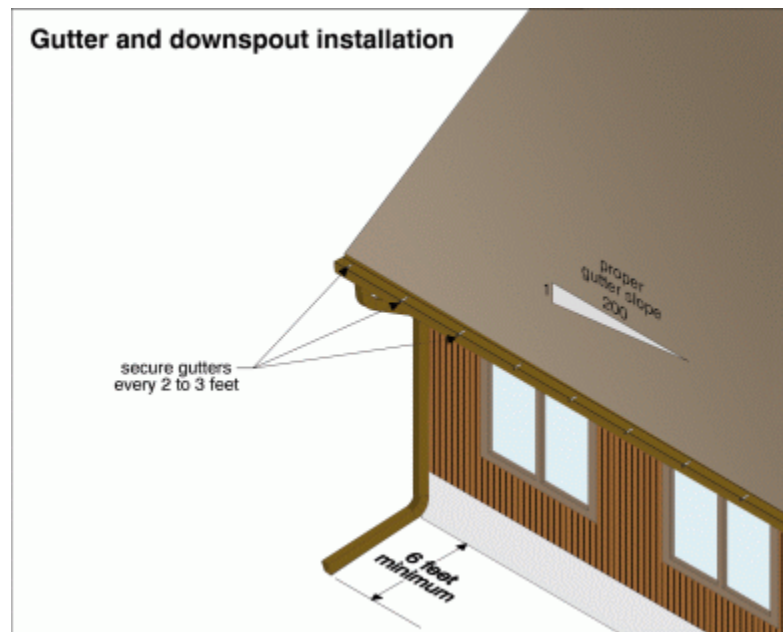
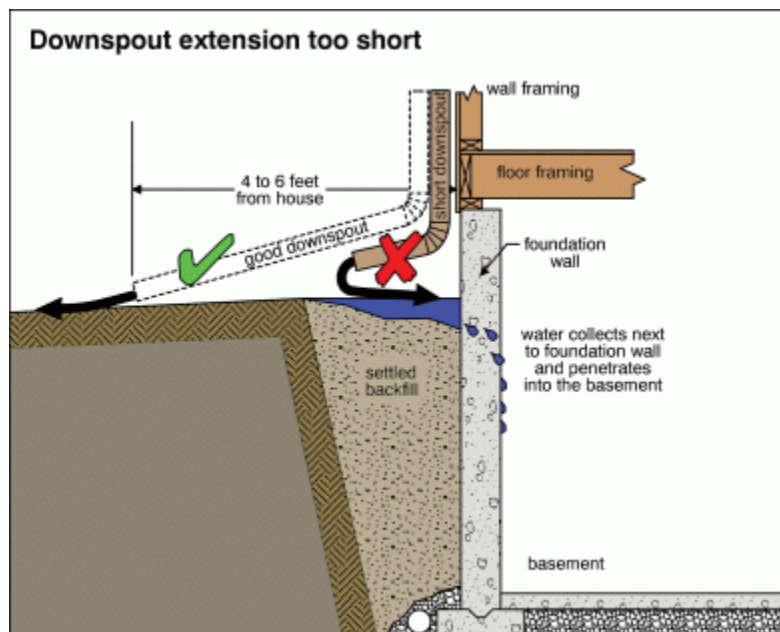
1. Condition: • [Downspouts end too close to building](#)

Time: Immediate

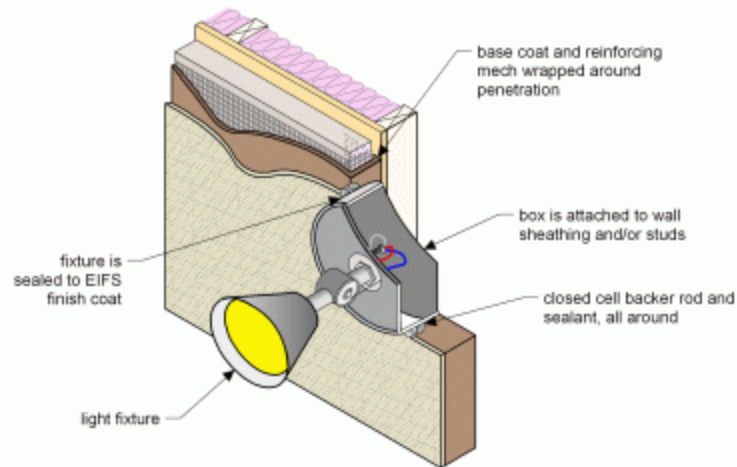
EIFS - light fixture detailing

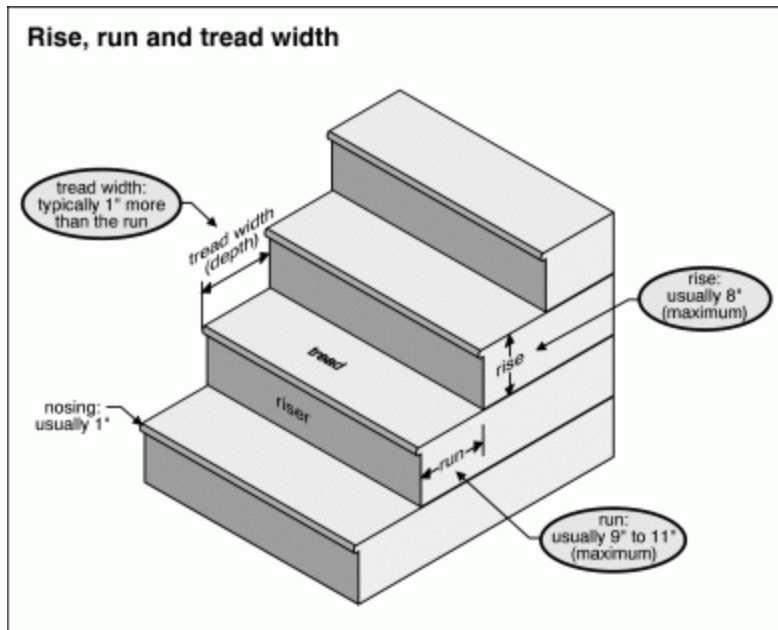
9. Condition: • [Rot](#)

Time: Immediate

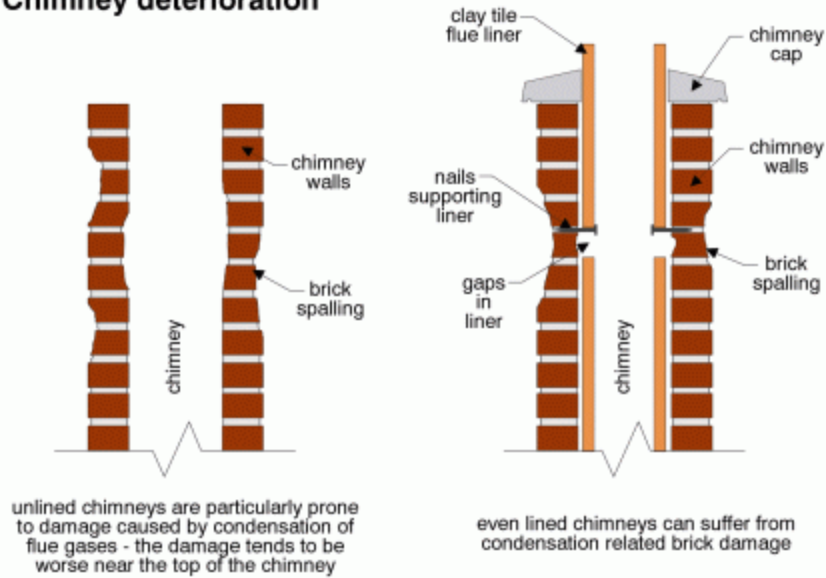
Chimney deterioration

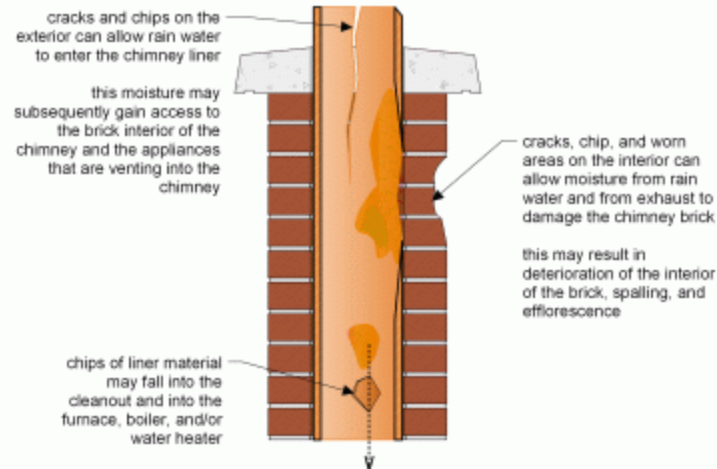
Deteriorated clay chimney liner

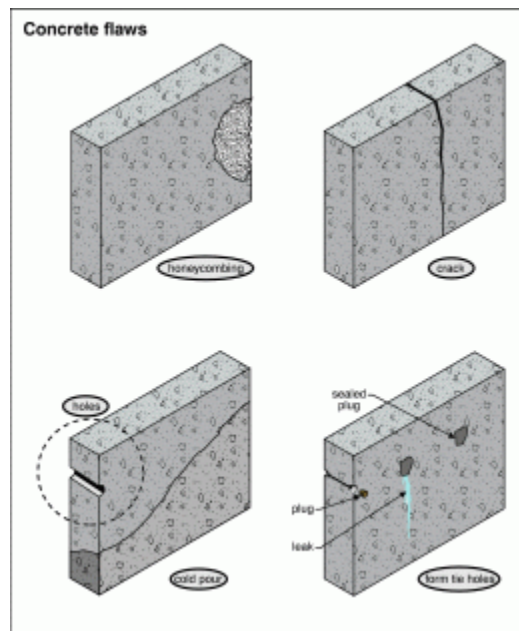
52. Condition: • [Form tie rod holes](#)

Implication(s): Chance of water damage to contents, finishes and/or structure

Location: Basement
