# Asbestos

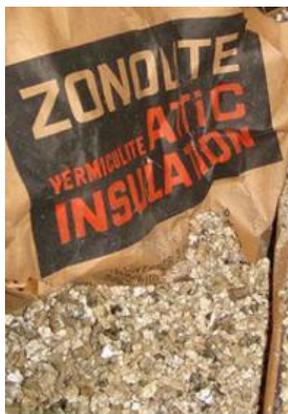
## **Vermiculite / Zonolite**

The concern with asbestos in vermiculite used in construction in the 1960s through the 1980s is a relatively recent, developing into an issue approximately 20 years ago. The basic problem with vermiculite asbestos (tremolite and actinolite) is that it is different than the types of asbestos that has been regulated since the 1970s. Existing regulations pertain to three other types of asbestos that, if present in a concentration of >1%, are regulated as an asbestos-containing material. However, many believe that tremolite and actinolite

Guidance for best practices for homeowners can be found at <http://www.epa.gov/asbestos/pubs/verm.html>. It is generally recommended that the vermiculite insulation be appropriately covered and left in place undisturbed. Removal is generally unnecessary unless required for renovation or demolition. Since vermiculite asbestos is often unregulated, opinions vary regarding proper safeguards and controls for homeowners and contractors working in attics. I am currently in discussions with installers to develop an understanding of their concerns and appropriate controls to allow the safe installation of additional insulation.

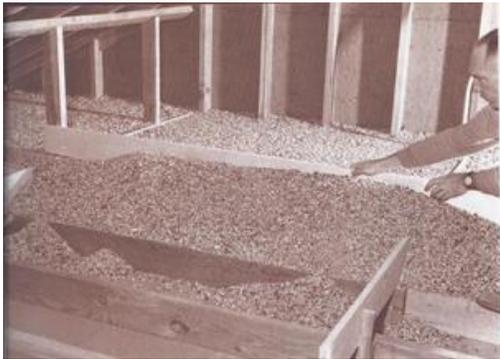
Many attic insulation installers are understandably concerned about working around vermiculite asbestos. Many simply refuse to work in an attic where vermiculite asbestos is present, regardless of whether it is present in a regulated concentration. However, there is no reason that additional attic insulation cannot be installed over asbestos

vermiculite with an unregulated concentration of <1% as long as some appropriate precautions are followed, especially since the asbestos present is often in the fine settled fraction rather than the coarse fraction of insulation at the surface. The lack of formal regulation gives you the opportunity for creative and flexible site-specific safety controls.

- For "inactive" attics where entry is very infrequent, it is recommended that Tyvek or an equivalent barrier be applied on top of the vermiculite insulation and additional insulation added above.
- For "active" attics where entry is fairly common due to household storage practices or if significant renovation activity is to be performed by contractors, it is recommended that a fogging and encapsulating spray sealant be applied to "lock-down" any fibers not trapped within the insulation. A barrier and additional insulation should then be applied. Visible dust accumulations should be cleaned from floorboards and other settling surfaces.

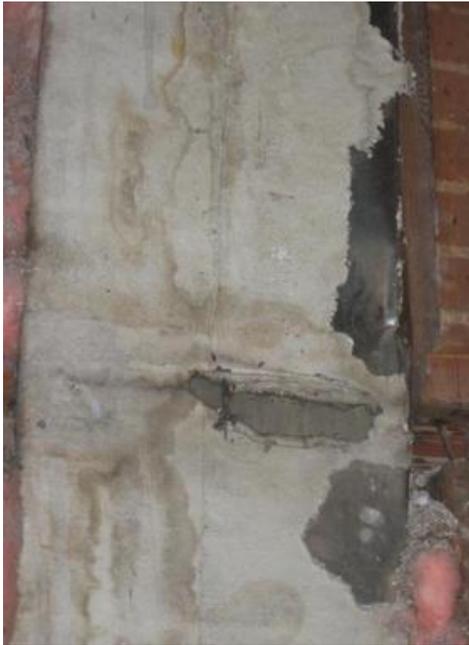
## **Asbestos on Ductwork**

In homes constructed in the 1920s through the 1950s sometimes had an asbestos fabric wrap insulation on the outside of sheet metal supply ducts. Sometimes this was added extensively to all the ducts (including inside the walls) and sometimes it was just added near perimeter walls or just on the duct elbows. Sometimes the ducts were uninsulated but the seams were sealed with an asbestos tape. Sometimes an asbestos shield was only installed directly over the top of the furnace on the main supply duct. Less common is asbestos insulation or asbestos board on the return air ducts. Occasionally, an asbestos board was affixed between the basement joists to form the

return air ducts. On rare occasions, an asbestos insulation was used inside the return air ducts near the perimeter wall to insulate the return air by forming a thermal barrier with the foundation. Unfortunately this hidden use of asbestos is hard to detect! Detection generally requires removing the return air vent covers, which is typically a destructive affair as the vents are typically heavily painted and removal causes damage to the adjacent wall.

If asbestos is found on your ducts, should it be abated (removed) before your ducts are cleaned? Actually, probably NOT! The only realistic and practical solution is to have the ducts removed in their entirety by an asbestos abatement contractor and then have new ducts installed. The only exception is if there is just a residual amount of insulation remaining or just the seams are taped. Do NOT waste money having an abatement contractor strip insulation from ductwork!

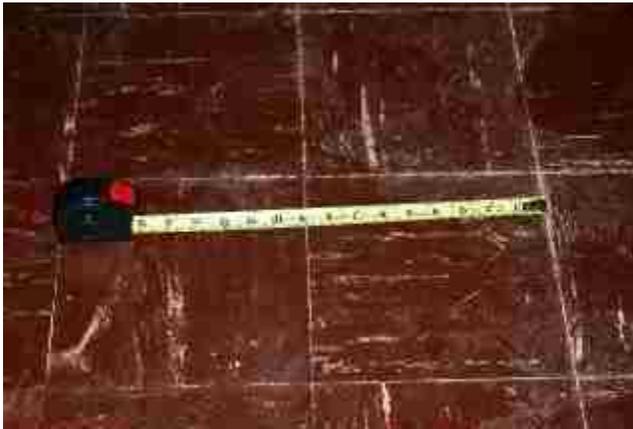
Armstrong floor tile - Rosato © Daniel

"Resilient flooring" is defined as materials softer than the non-resilient flooring materials such as stone, slate, brick, ceramic tile. Resilient flooring materials include organic types of flooring: asphalt based floor tiles, rubber floor tiles, vinyl-asbestos floor tiles, linoleum, and plastic tile.

Many older floor tiles contained asbestos. It is possible to match a size and pattern to a manufacturer to help assist in determining if asbestos was utilized, but this can be difficult. A sample can be taken and reviewed at a lab which is the best way to assess the risk.

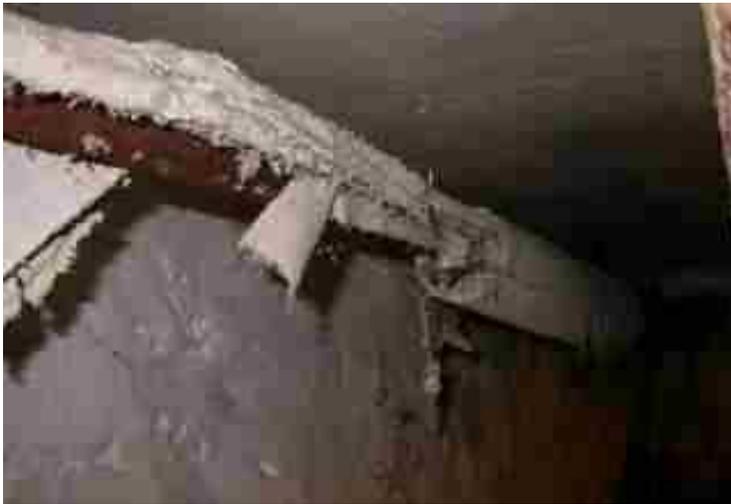
## Pipe Insulation:

Pipe insulation or pipe covering remains one of the most hazardous asbestos products found in homes and buildings. It was often used to control the temperature of hot pipes typically with steam or hot water heating systems. Pipe covering that is found today is usually old, crumbly and therefore very hazardous. Air

Cell pipe insulation was a very common type. Recommend testing to properly assess the risk.

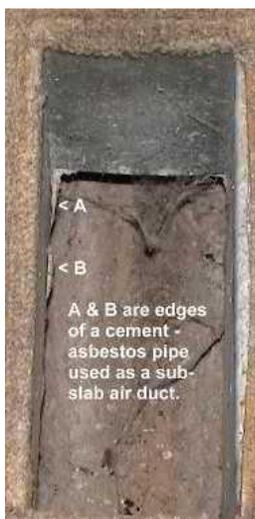
## Transite Piping:

Transite pipe, which contains significant percentage of asbestos fibers, was often used for heating ducts. Transite pipe used as HVAC ducts or air ducts for heating and air conditioning was often installed buried in a concrete floor slab - methods that placed the asbestos-cement transite piping below or in a building floor slab. While it's cementitious, transite ducts or even transite pipe used for heating flue vents is a potential asbestos hazard in buildings. Transite pipe typically contains about 15% to 25% asbestos fibers, typically fibrous chrysotile asbestos. A careful asbestos testing lab may report both fibrous and fragmented asbestos which can occur in

exposure to asbestos). The balance will be cement and possibly other fibers or binders. If transite pipe is damaged or is cut mechanically (such as by using power equipment), friable, airborne asbestos fibers may be generated - a health and costly cleanup concern.
