INSPECTION REPORT

For the Property at:
23730 KELLY RD
EASTPOINTE, MI

Prepared for: EDDIE SADIK
Inspection Date: Tuesday, February 25, 2014
Prepared by: Christopher Daggy

Report No. 1781

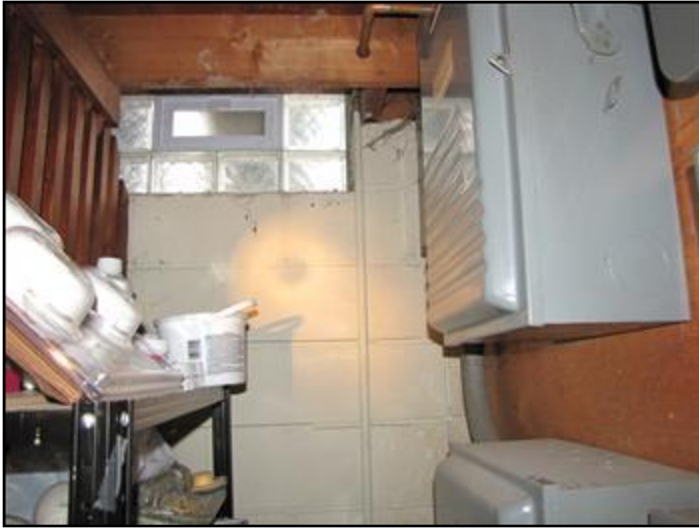
Condition: • [Settled](#)

Extensive settlement noted. This includes the basement and crawl space area. Suspect movement will continue.

1. Settled

Repairs could be extensive to stabilize and correct prior movement. Recommend review by a professional engineer that specializes in structures.

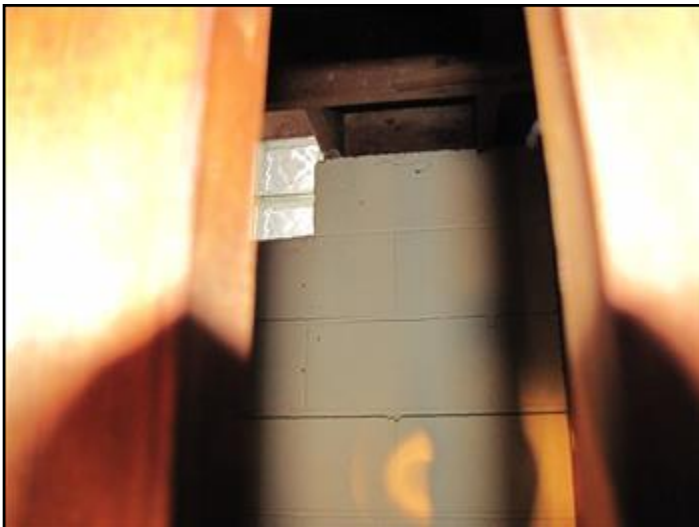
3. Settled

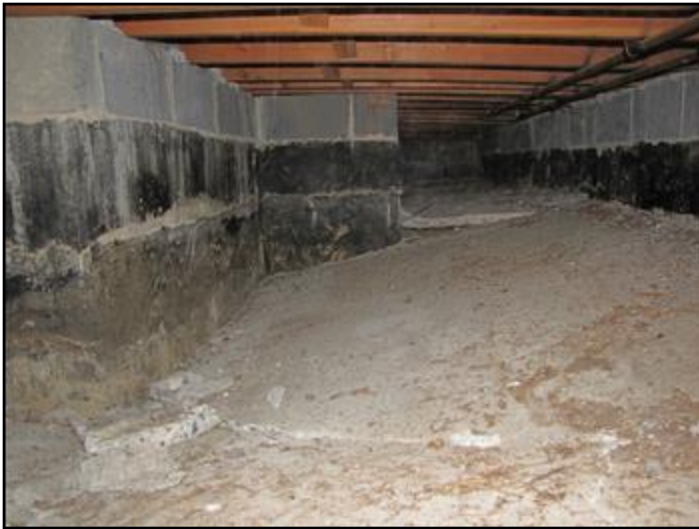
5. Settled

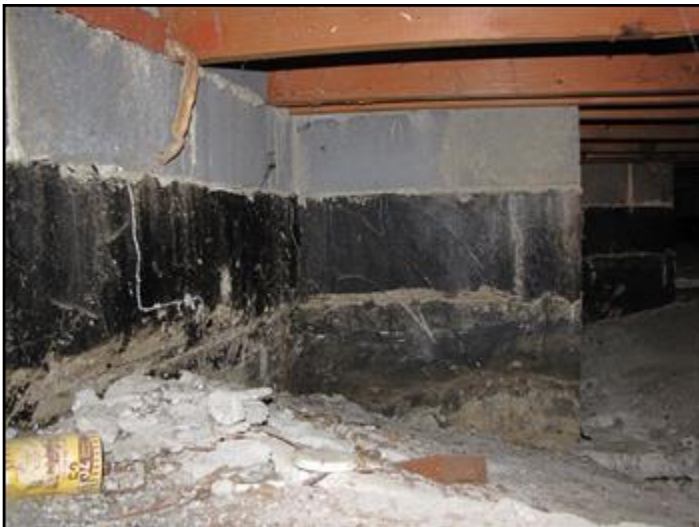
7. Settled

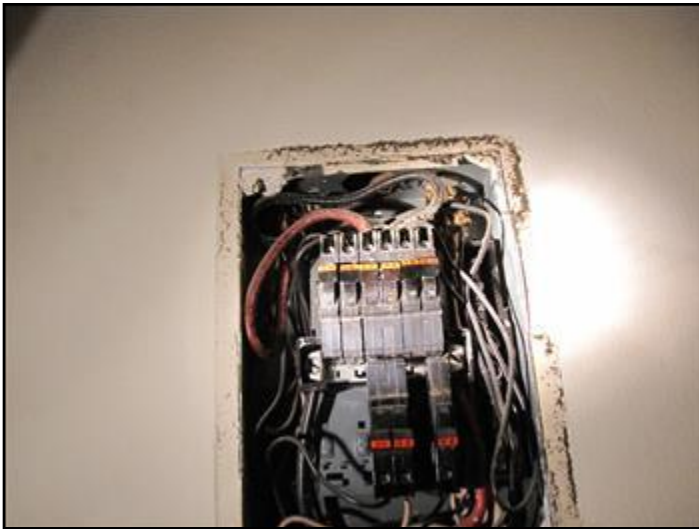
10.

Condition: • [Federal Pacific Panels utilized. These panels are linked with fire concerns. See attached link. Have panels reviewed by a licensed electrician. Replace panels if recommended.](#)

Task: Further evaluation

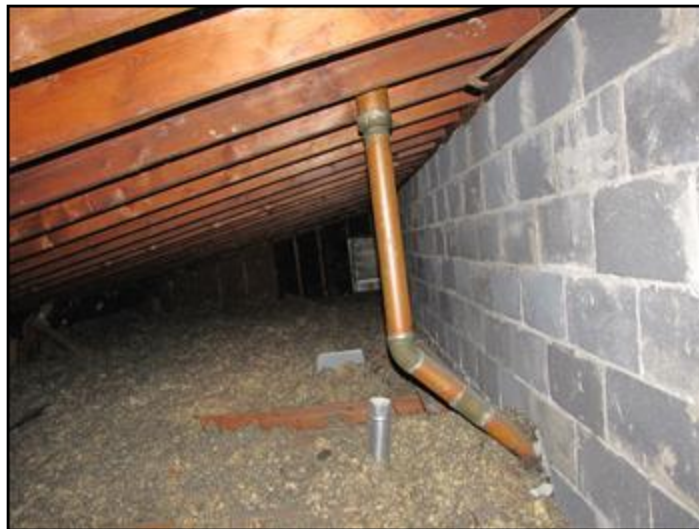
Condition: • [Poor termination location](#)

Bathroom exhaust fans: Recommend vent to exterior.

Implication(s): Chance of condensation damage to finishes and/or structure

12. Poor termination location

Task: Improve

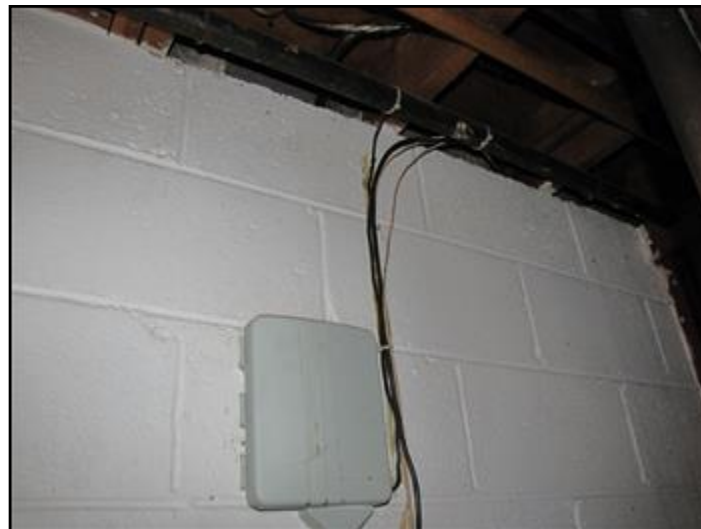
36. Landscape sprinklers present.

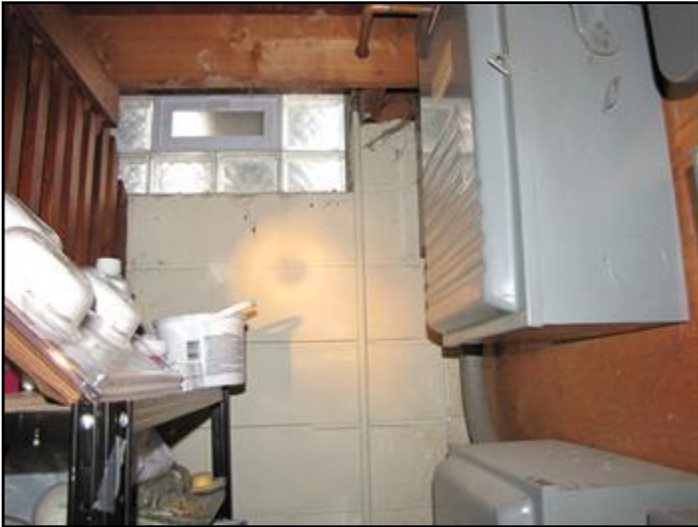
41. Settled

9. Condition: • [Settled](#)

Extensive settlement noted. This includes the basement and crawl space area. Suspect movement will continue. Repairs could be extensive to stabilize and correct prior movement. Recommend review by a professional engineer that specializes in structures.

Task: Further evaluation

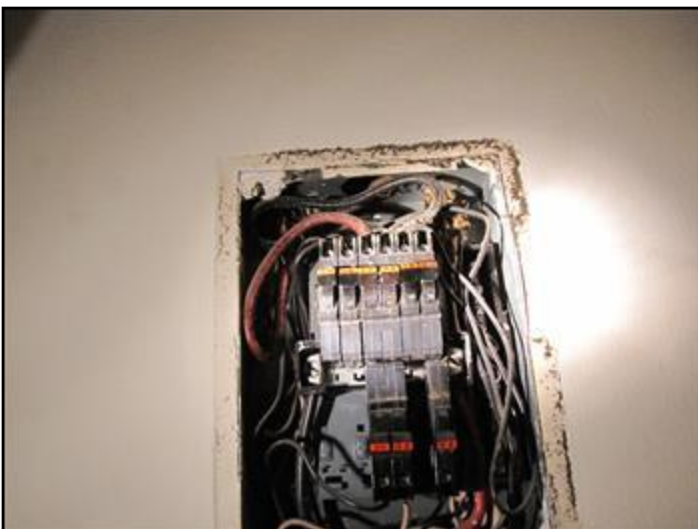
57.

14. **Condition:** • [Federal Pacific Panels utilized. These panels are linked with fire concerns. See attached link. Have panels reviewed by a licensed electrician. Replace panels if recommended.](#)

Task: Further evaluation

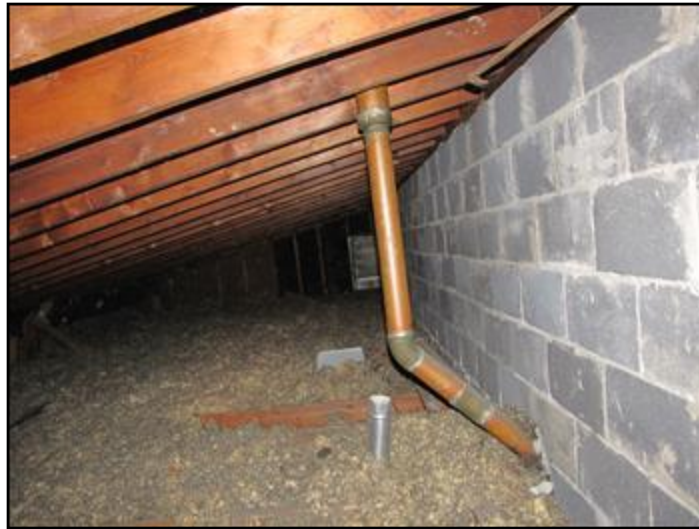
33. **Condition:** • [Poor termination location](#)

Bathroom exhaust fans: Recommend vent to exterior.

Implication(s): Chance of condensation damage to finishes and/or structure

190. Poor termination location

Task: Improve

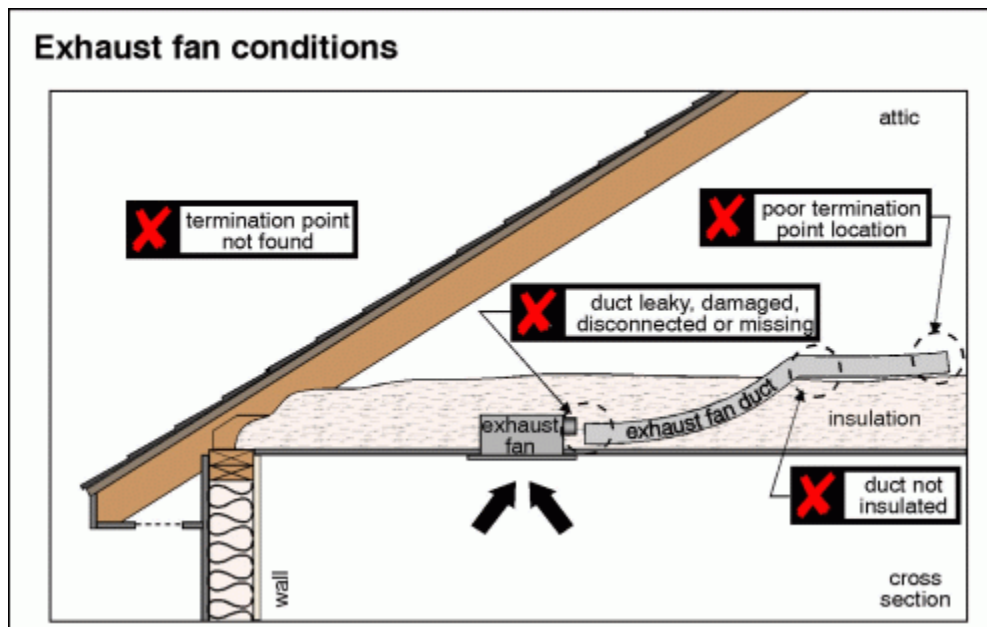
34. Condition: • Not vented to exterior

Implication(s): Chance of condensation damage to finishes and/or structure

Task: Repair
