INSPECTION REPORT

For the Property at:
123 MAIN ST
BLOOMFIELD HILLS, MI 48304

Prepared for: ANN SMITH
Inspection Date: Monday, November 2, 2015
Prepared by: Christopher Daggy

Report No. 2217, v.3

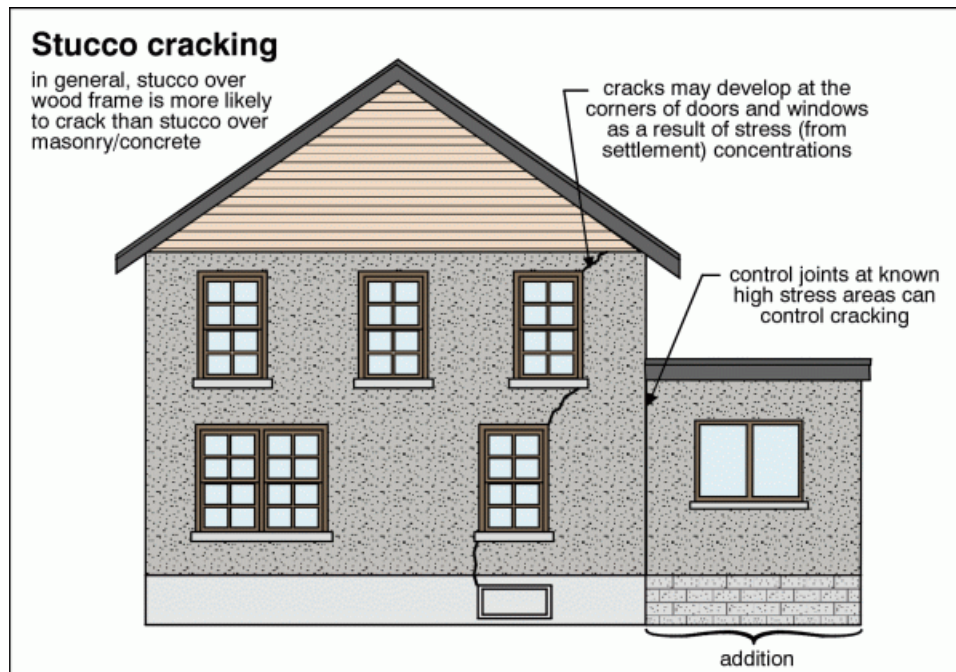
Condition: • [Cracked](#)

Implication(s): Chance of water damage to contents, finishes and/or structure | Material deterioration

Task: Further evaluation

Time: Immediate

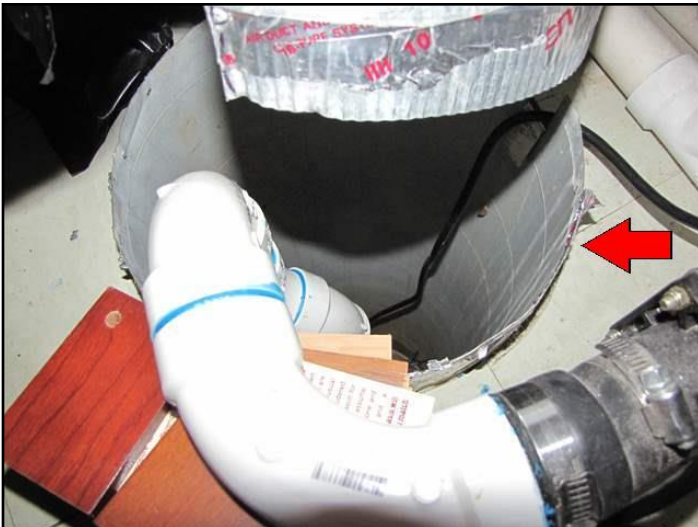
18.

Condition: • The ductwork that feeds the basement is located under the slab. Water has been entering the ductwork. A sump has been dropped into the duct to remove the water. The ductwork is not designed to have water enter and it could cause deterioration of the ductwork and mold growth. Recommend removal of sump pump. Repairs could be extensive to correct.

Task: Further evaluation

Time: Immediate

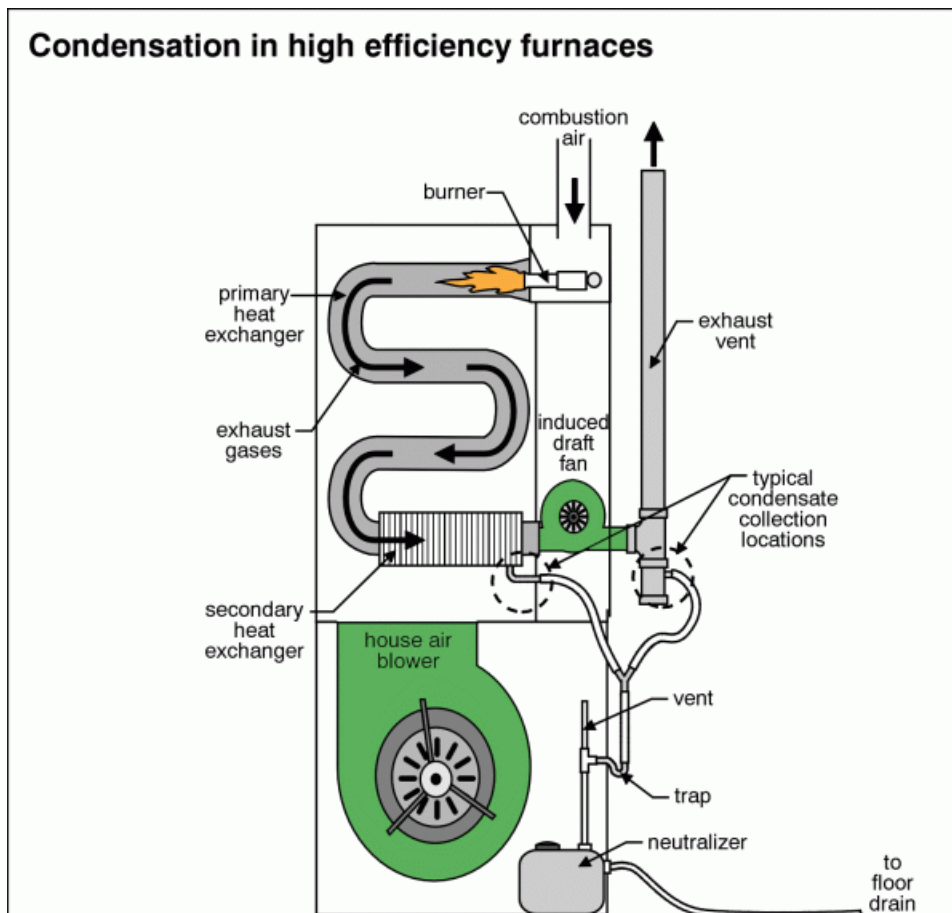
Condition: • [Condensate problems](#)

Condensate from exhaust and from air conditioning drains into a 5 gallon bucket which has a sump pump. Recommend review of design.

Task: Improve

Time: Immediate

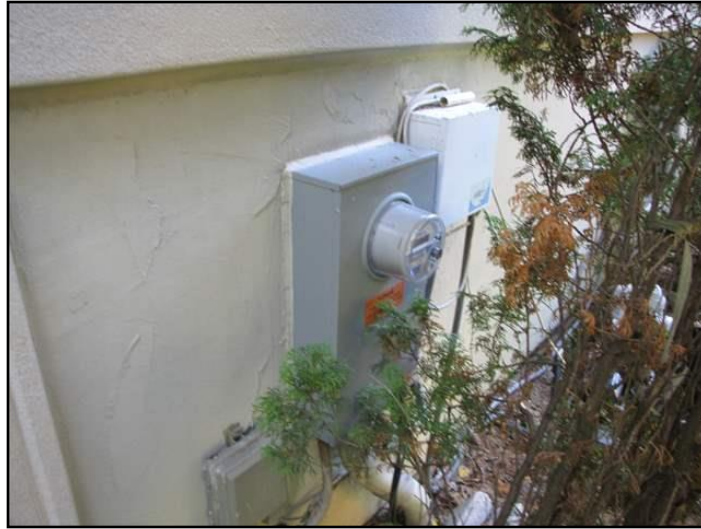
77. Underground aluminum

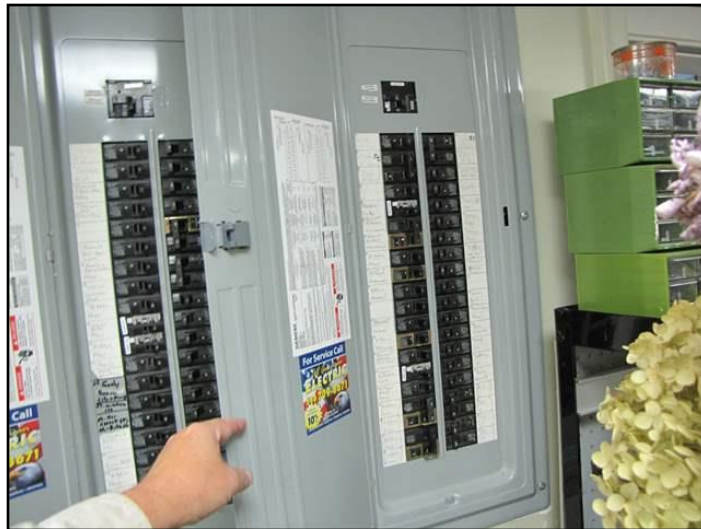
78. Breakers - basement

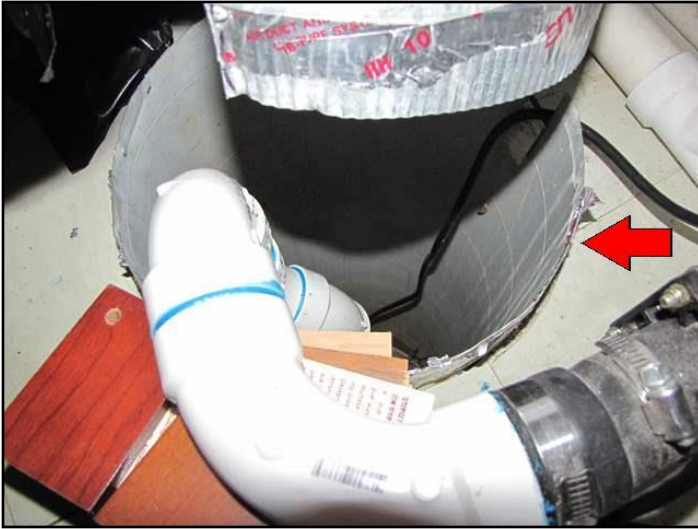
119.

23. Condition: • The ductwork that feeds the basement is located under the slab. Water has been entering the ductwork. A sump has been dropped into the duct to remove the water. The ductwork is not designed to have water enter and it could cause deterioration of the ductwork and mold growth. Recommend removal of sump pump. Repairs could be extensive to correct.

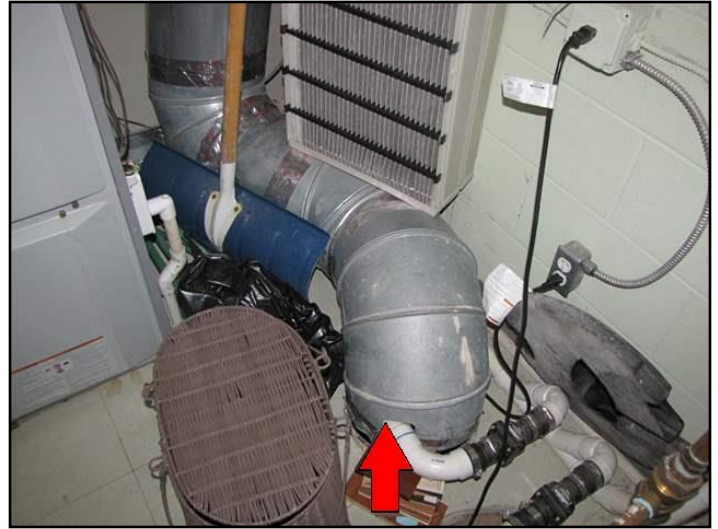
120.

24. Condition: • [Condensate problems](#)

Condensate from exhaust and from air conditioning drains into a 5 gallon bucket which has a sump pump. Recommend review of design.

Implication(s): Chance of water damage to contents, finishes and/or structure | Reduced system life expectancy

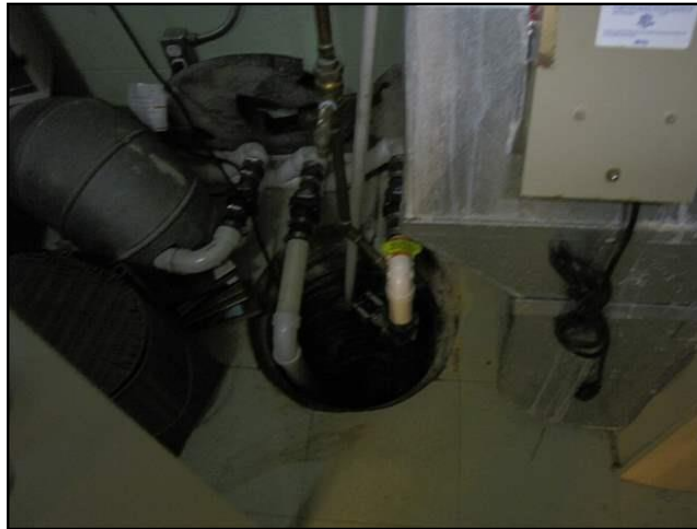
135. Back up sump pump: Siphon Jet

31. **Condition:** • Back up sump pump has evidence of corrosion and leaks.

Task: Replace

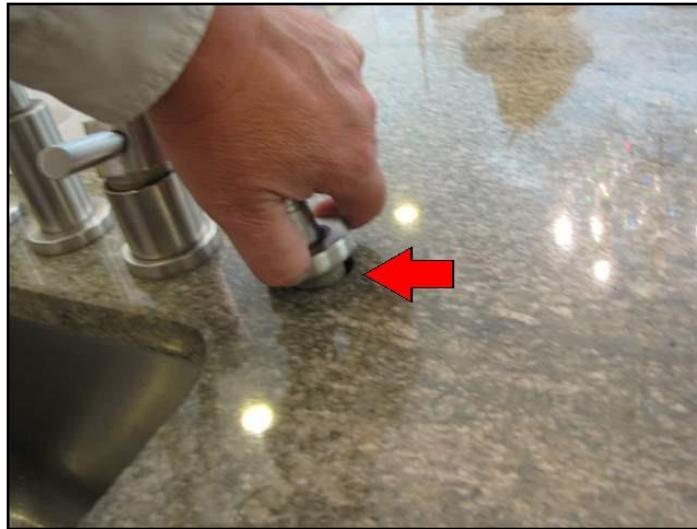
136.

35. Condition: • [Drip, leak](#)

Implication(s): Chance of water damage to contents, finishes and/or structure

Task: Repair

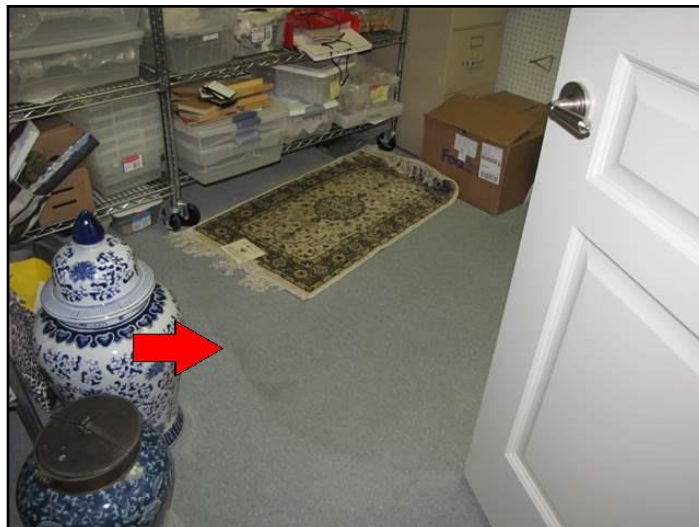
183.

Evidence of basement leakage: • Water stain at carpet in basement.
