INSPECTION REPORT

For the Property at:
123 Sample St.
FARMINGTON HILLS, MI 48335

Prepared for: John Doe
Inspection Date: Thursday, October 14, 2010
Prepared by: Christopher Daggy

RE: Report No. 1016
123 Sample
Farmington Hills, MI
48335

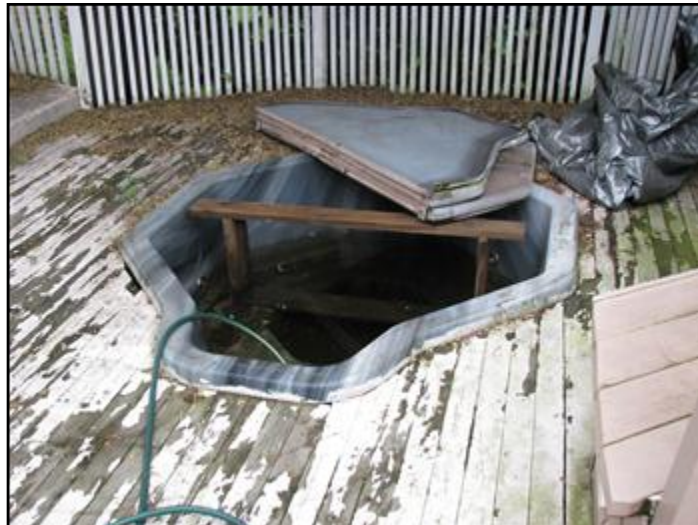
1.

General: • Exterior hot tub not operated or inspected.

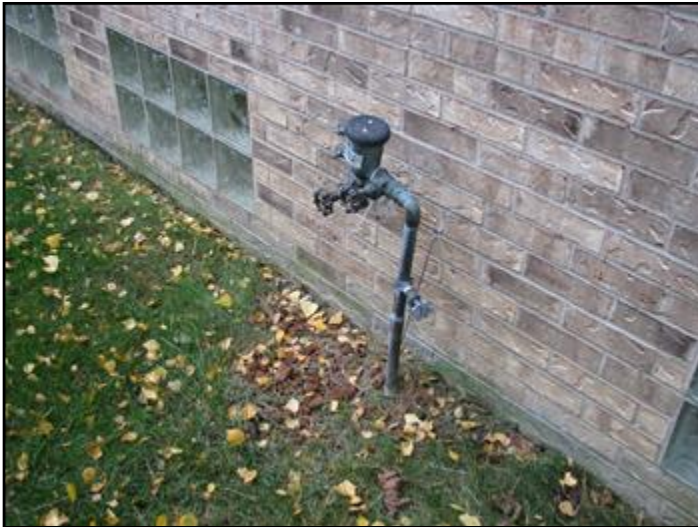
2.

General: • Landscape sprinklers not operated or inspected. Water off to system.

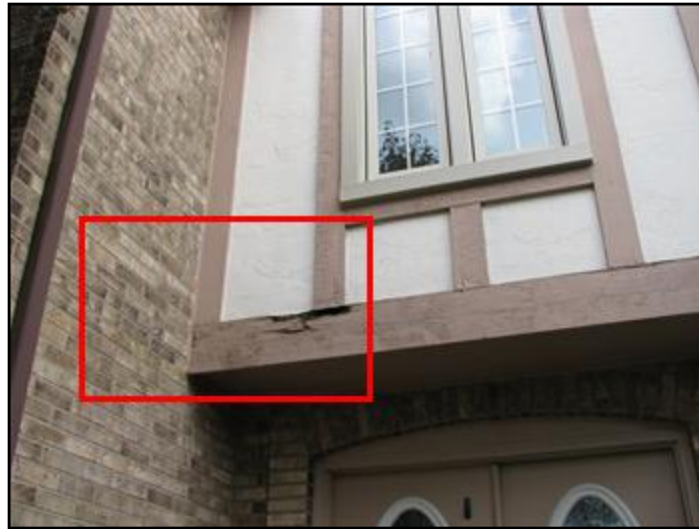
11.

4. Condition: • [Moisture penetration](#)

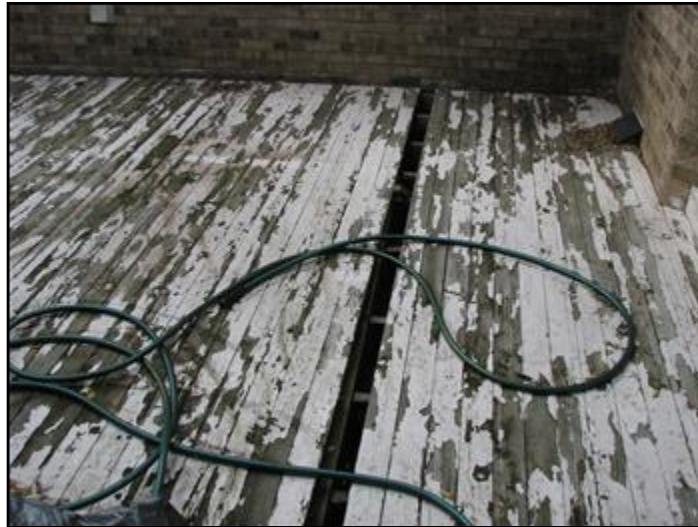
13.

9. Condition: • [Rot](#)

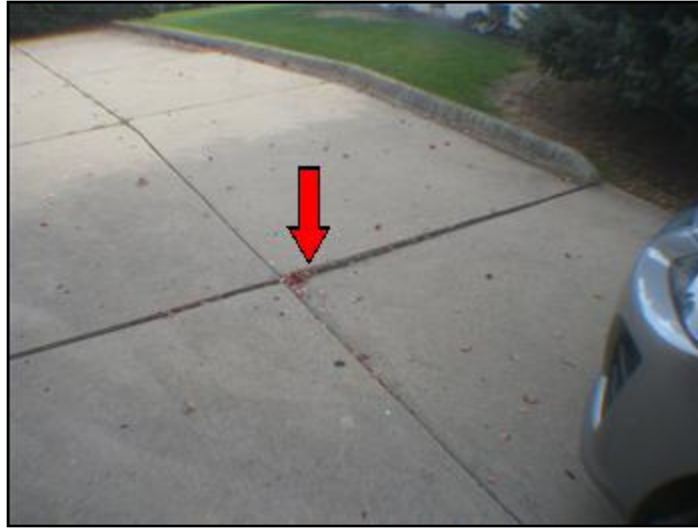
19.

LANDSCAPING \ General**14. Condition:** • Landscaping overgrown and in poor condition.**Location:** Exterior**Task:** Improve**Time:** Discretionary**Cost:** Depends on approach**15. Condition:** • [Trees or shrubs too close to house](#)**Implication(s):** Chance of water damage to contents, finishes and/or structure | Chance of pests entering house | Material deterioration**Location:** Exterior**Task:** Improve**Time:** Immediate**Cost:** \$500

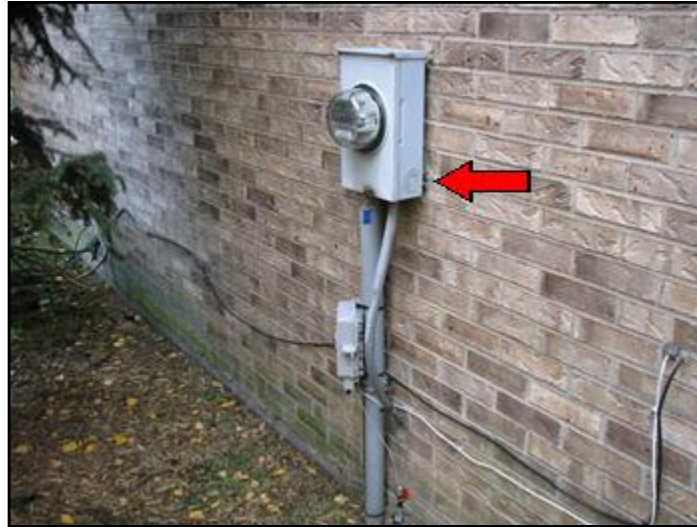
23.

- [Underground aluminum](#)

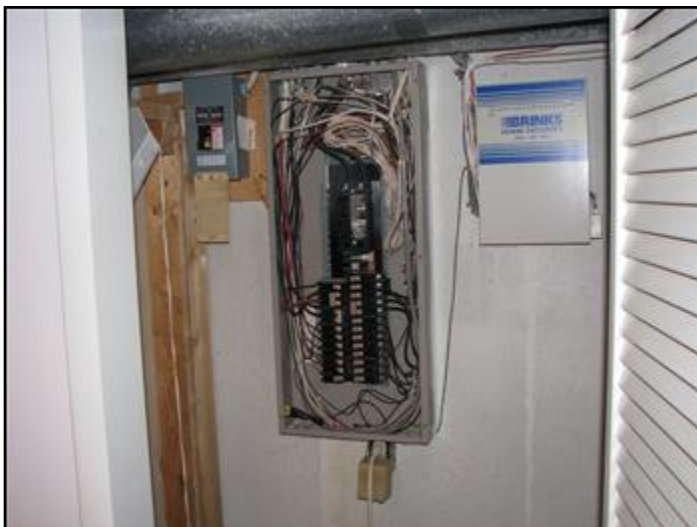
24.

Service size: • [150 Amps \(240 Volts\)](#)**Main disconnect/service box rating:** • [150 Amps](#)**Main disconnect/service box type and location:**

- [Breakers - basement](#)

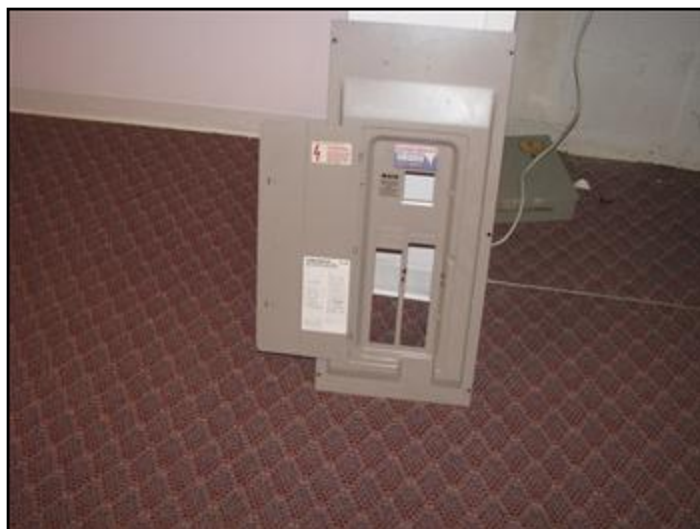
26.

System grounding material and type: • [Copper - water pipe](#) • [Aluminum - ground rods](#)

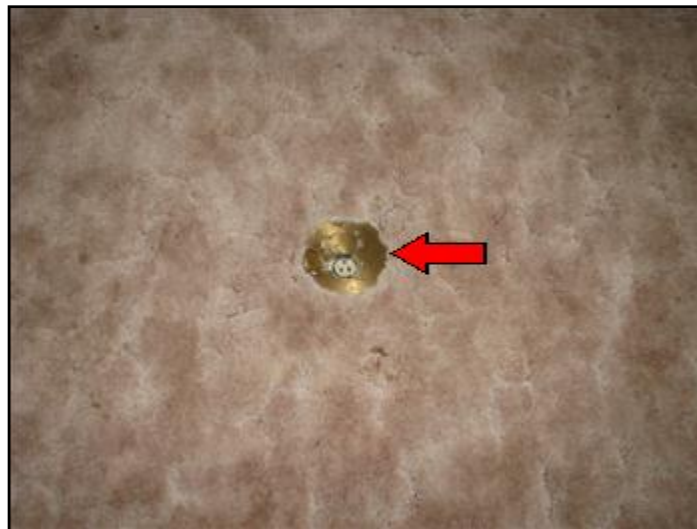
**27.****29. Condition:** • [No GFI \(Ground Fault Interrupter\)](#)**Implication(s):** Electric shock**Location:** Various Basement Second Floor Bathroom Kitchen**Task:** Repair**Time:** Immediate**Cost:** Less than \$100

26. Condition: • [Conventional lights in wet areas](#)**Implication(s):** Electric shock | Fire hazard**Location:** Second Floor Bathroom**Task:** Replace**Time:** Immediate**Cost:** Less than \$100**27. Condition:** • [Missing](#)**Implication(s):** Inadequate lighting**Location:** Foyer**Task:** Replace**Time:** Immediate**Cost:** Depends on approach**DISTRIBUTION SYSTEM \ Outlets (receptacles)****28. Condition:** • [Damage](#)**Implication(s):** Electric shock | Fire hazard**Location:** First Floor Family Room**Task:** Replace**Time:** Immediate**Cost:** Less than \$100

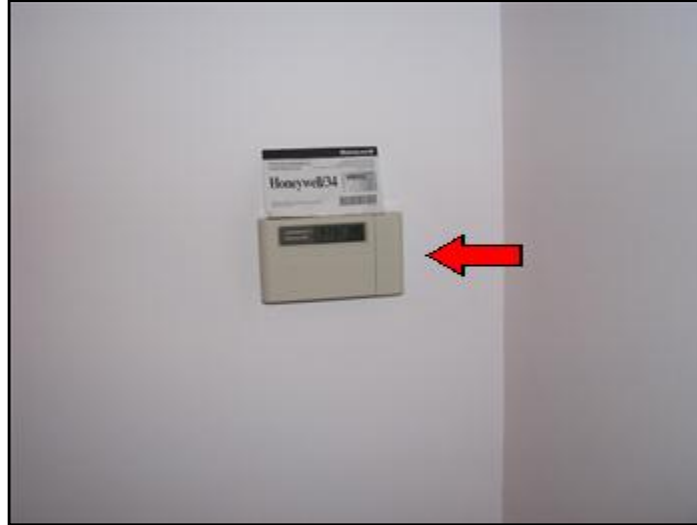
28.

General: • Thermostat: Electronic

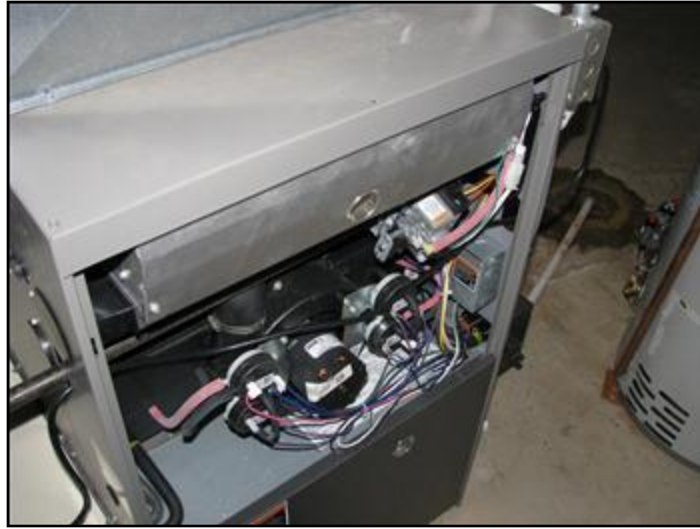
31.

Furnace manufacturer: • Lennox

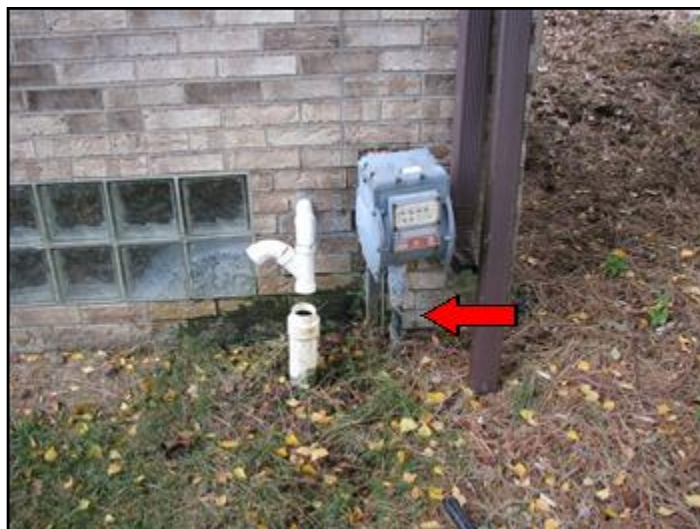
32.

• Meter

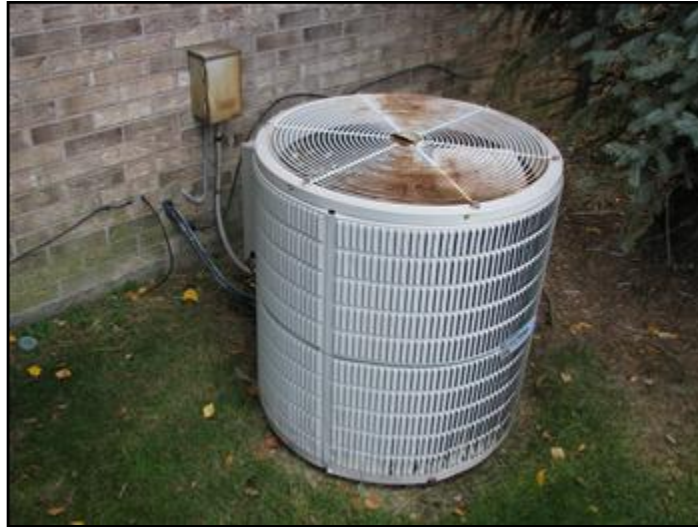
38.

Compressor approximate age: • 24 years**Typical life expectancy:** • 12 to 15 years**Failure probability:** • [High](#)

AIR CONDITIONING \ Life expectancy**36. Condition:** • [Old](#)**Implication(s):** Equipment failure | Reduced comfort**Task:** Further evaluation

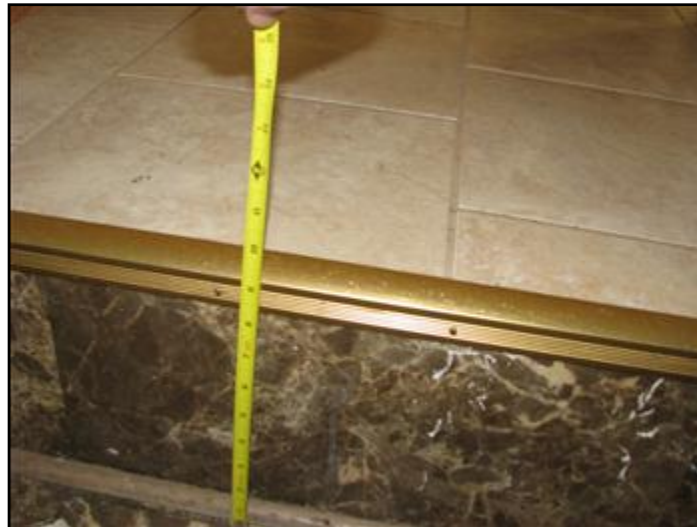
55.

46. Condition: • Trip hazard due to stair height

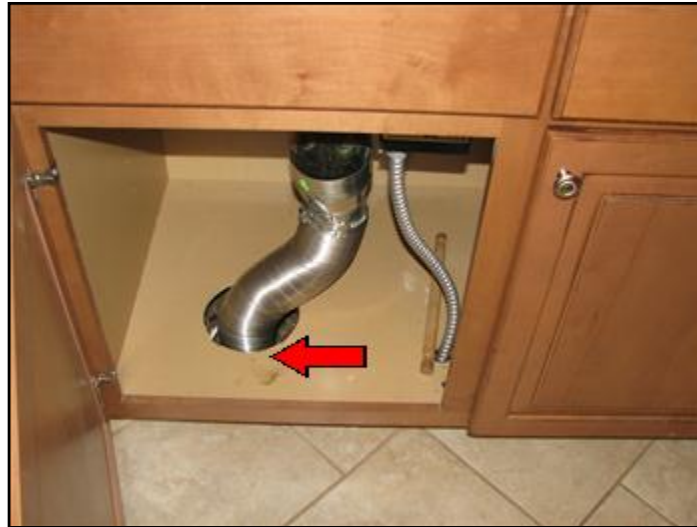
57.

56. Condition: • Venting arrangement poor

Task: Repair

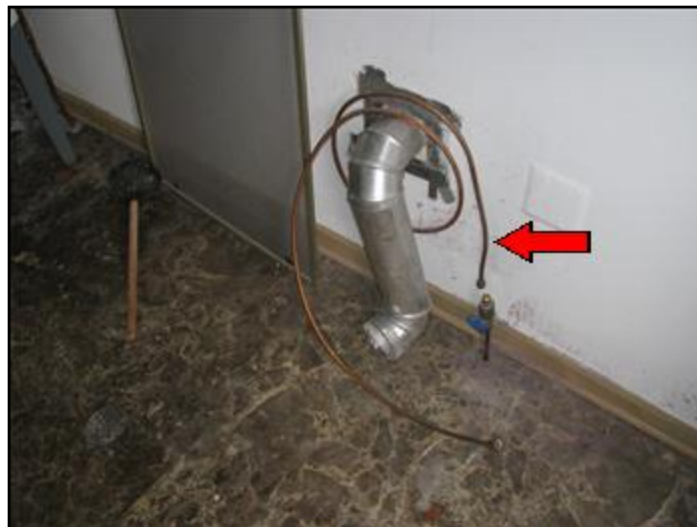
58.

57. Condition: • [Copper gas connector](#)

Task: Repair
